Georgia-Pacific LLC

**Mill Pond Dam Maintenance Work
Plan**

Former Georgia-Pacific Wood Products Facility

August 2010

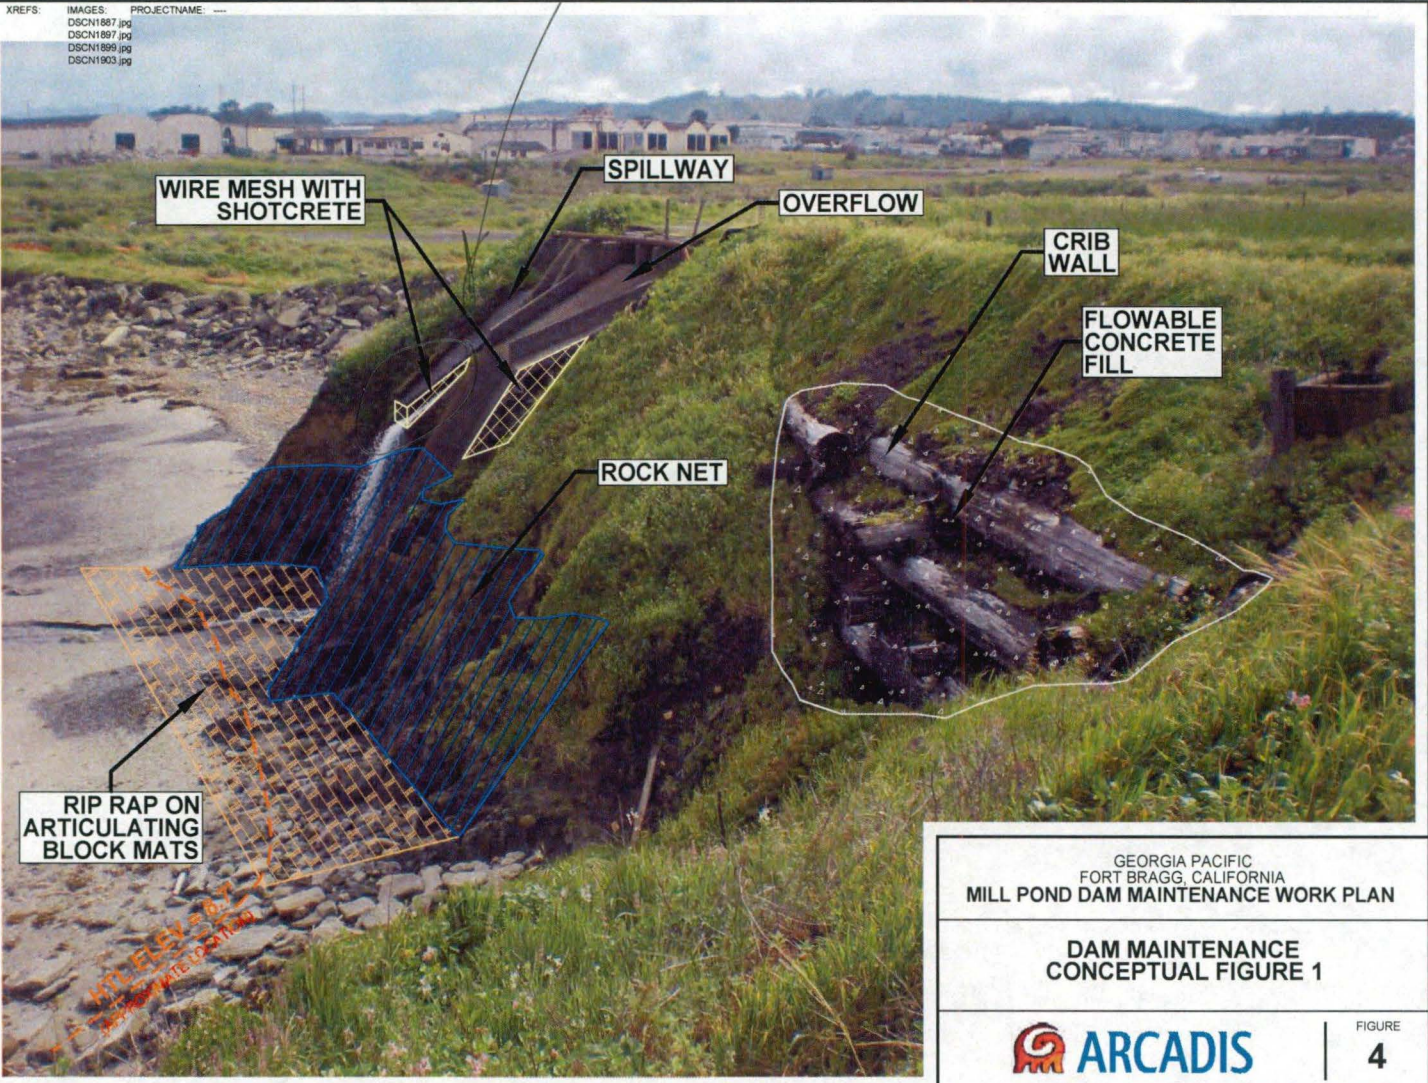
FIGURE
4

As is typical of the coastal bluffs in California, the dam has experienced erosion due to weathering. Specifically, the spillway and overflow structure have experienced erosion at the toe of and underneath these structures. Large pieces of the concrete have broken off of these structures as a result and lay on the beach below. Erosion has also occurred in and around the timber crib wall. In addition, portions of the exposed rock in the dam have undergone erosion, weathering, and spalling creating significant undercutting and crevices in portions of the rock face.

DAM MAINTENANCE
CONCEPTUAL FIGURE 1

- filling the crevices and voids in the dam wall and beneath the spillway and overflow structures with shotcrete

- filling the voids within the crib wall with flowable concrete fill
- installing rock netting over the dam wall to prevent rock fall and raveling
- installing articulating block concrete mats (AB Mats) at the base of the wall extending onto the beach to reduce erosion and scour at the toe of the dam
- installing riprap on top of the AB mats and along the toe of the dam face.

After the flowable concrete fill and shotcrete have been installed, a rock net will be attached to the face of the dam to the approximate limits shown on Figures 4 through 8. The final limits of the rock net will be

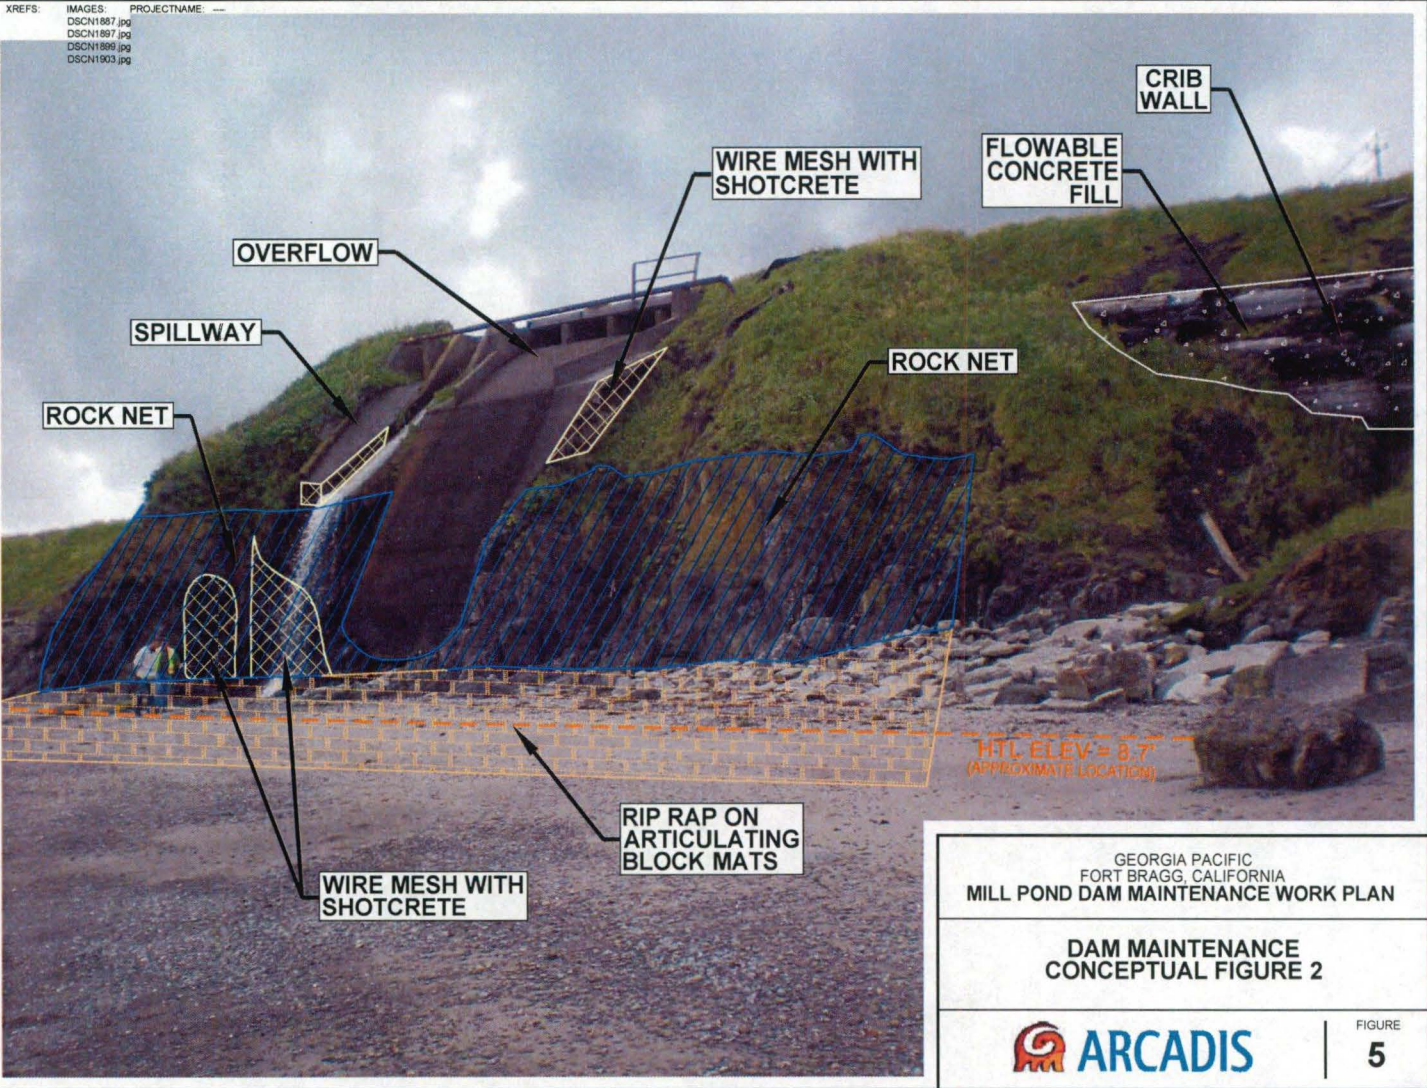
Water from the spillway currently falls onto the dam face; see Figure 6. It is anticipated that to complete the work, the contractor will need to temporarily divert this water away from the face of the dam. The contractor will propose a method for diverting this water. ARCADIS anticipates that the water will either be temporarily pumped around the spillway or that a temporary extension to the spillway will be constructed so that the water falls further away from the dam face.

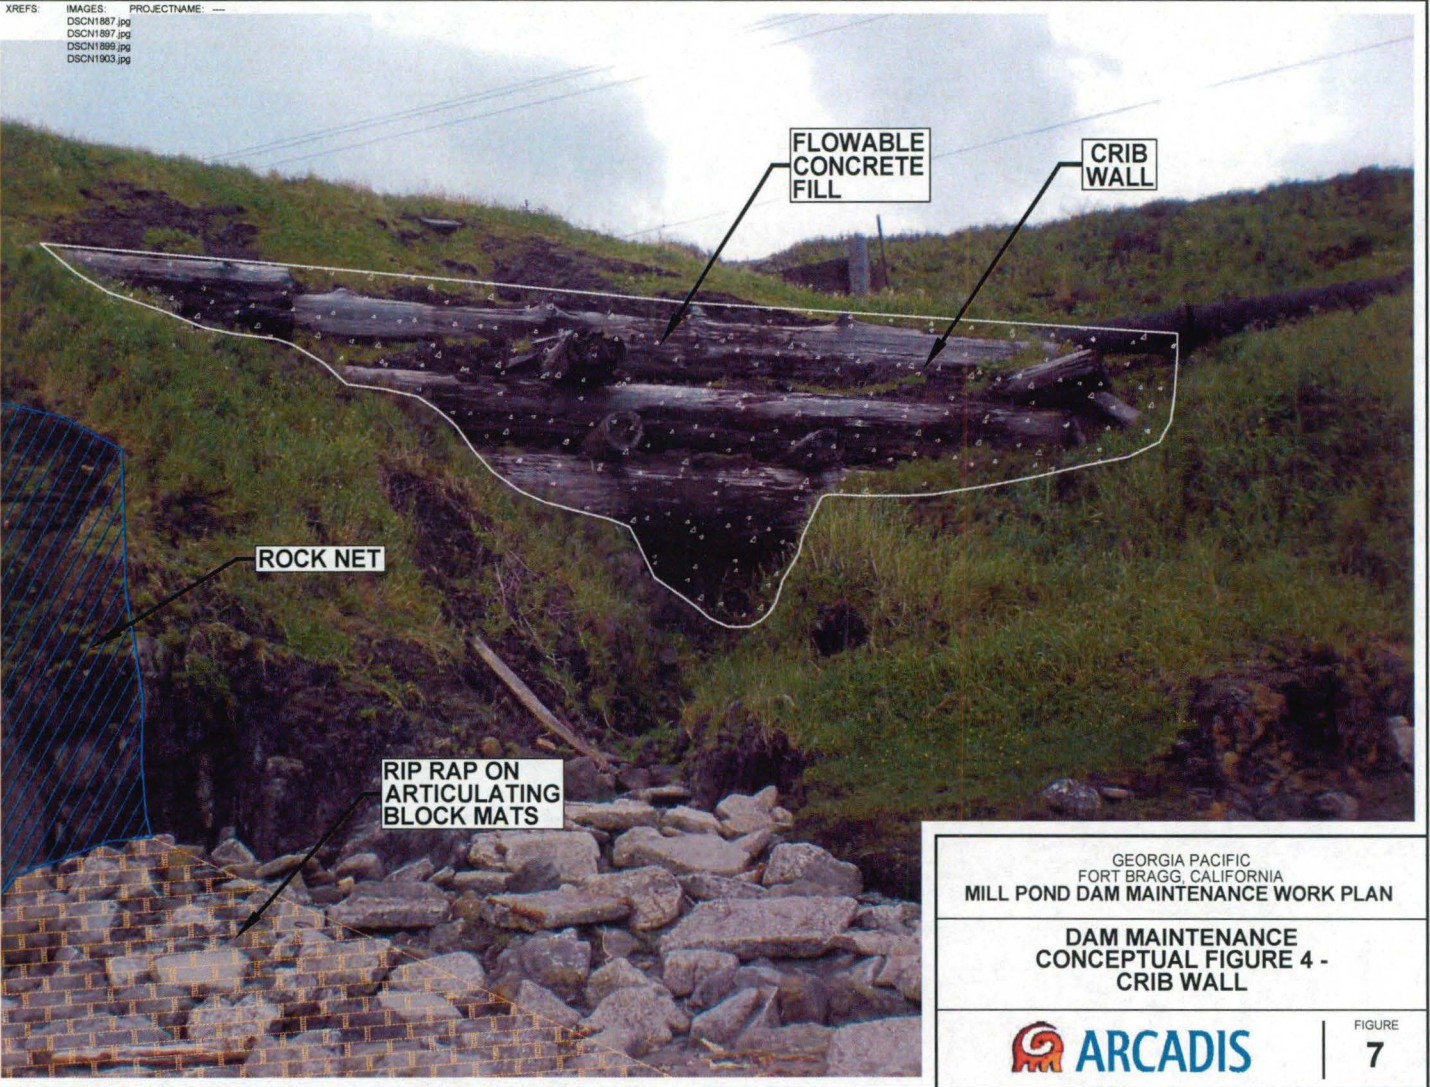
DAM MAINTENANCE
CONCEPTUAL FIGURE 4 -
CRIB WALL

Vegetation, loose soil, loose rock, and any other loose or deleterious material in the vicinity of the crib wall and within the voids of the crib wall will be removed using hand tools. The vegetation and soil removed will not be allowed to fall onto the beach, but will be stockpiled at an approved location and/or properly disposed. After this material has been removed from the crib wall, the surface of the logs which comprise the crib wall will be pressure washed to remove any remaining deleterious material.

The voids within the crib wall will be filled with a flowable concrete fill. The fill will have a minimum 28-day compressive strength of 200 pounds per square inch (psi). The fill will be placed in lifts approximately equal to the height of the individual logs which comprise the crib wall. Each lift will be allowed to cure for a minimum of 24 hours before the next lift is placed. Drainage material such as geocomposite or PVC piping will be placed between lifts and run the full width of the lifts, back to front, to provide a drainage path for seepage behind the fill and to prevent the buildup of excess hydrostatic pressure. This is intended to prevent excessive hydrostatic forces from being exerted on the crib wall. The contractor may use temporary form work, as needed, to keep the fill in place while it is being placed. The contractor will propose a method for preventing the fill from inadvertently spilling and flowing onto the beach. Such measures may include the construction of a temporary berm on the beach. All heavy equipment necessary for the production and placement of the fill will be staged on top of the dam, not on the beach. The contractor will collect two samples of the flowable concrete fill in test cylinders. The samples will be subjected to testing at 7 and 28 days of cure time to determine the compressive strength of the material. Sample collection and testing procedures will follow the guidelines established in American Society for Testing and Materials D4832-10.
