The Resources Agency
DEPARTMENT OF WATER RESOURCES
Division of Safety of Dams

Memorandum of Conference

Mill Pond Dam and Reservoir, No. 2381
Mendocino County
March 17, 2015

Georgia-Pacific Mill Pond Dam Project Update

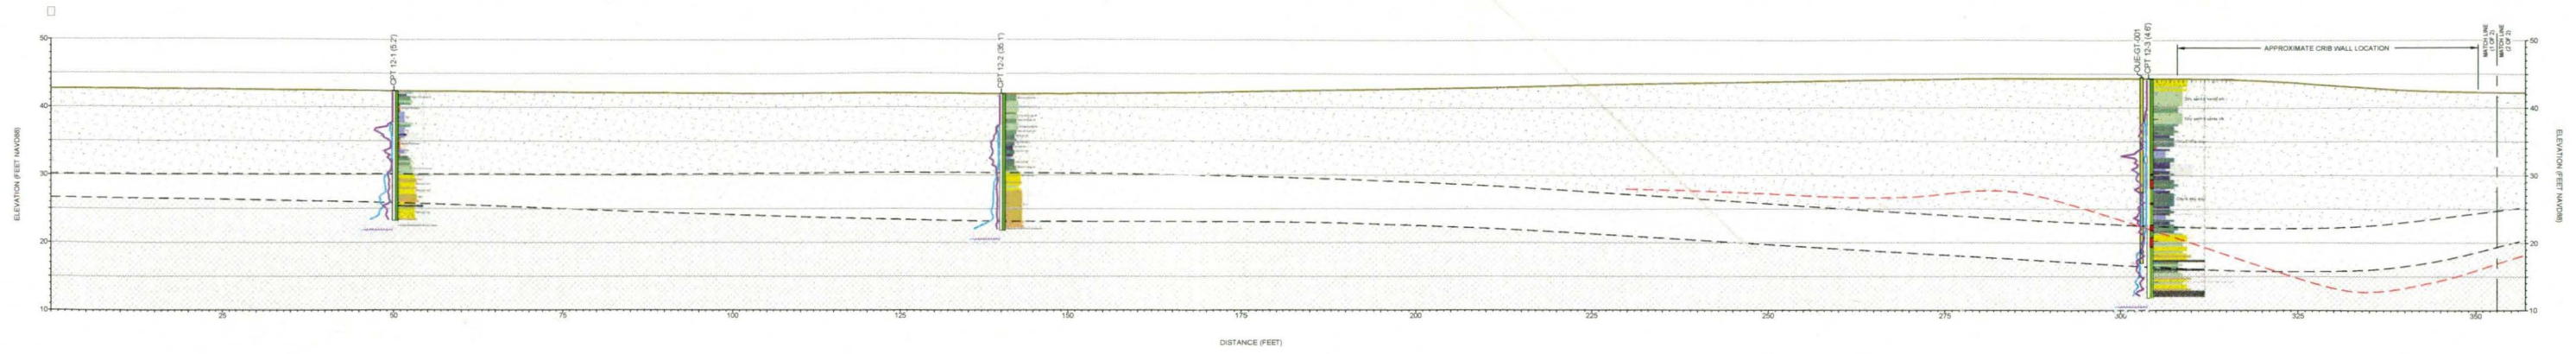
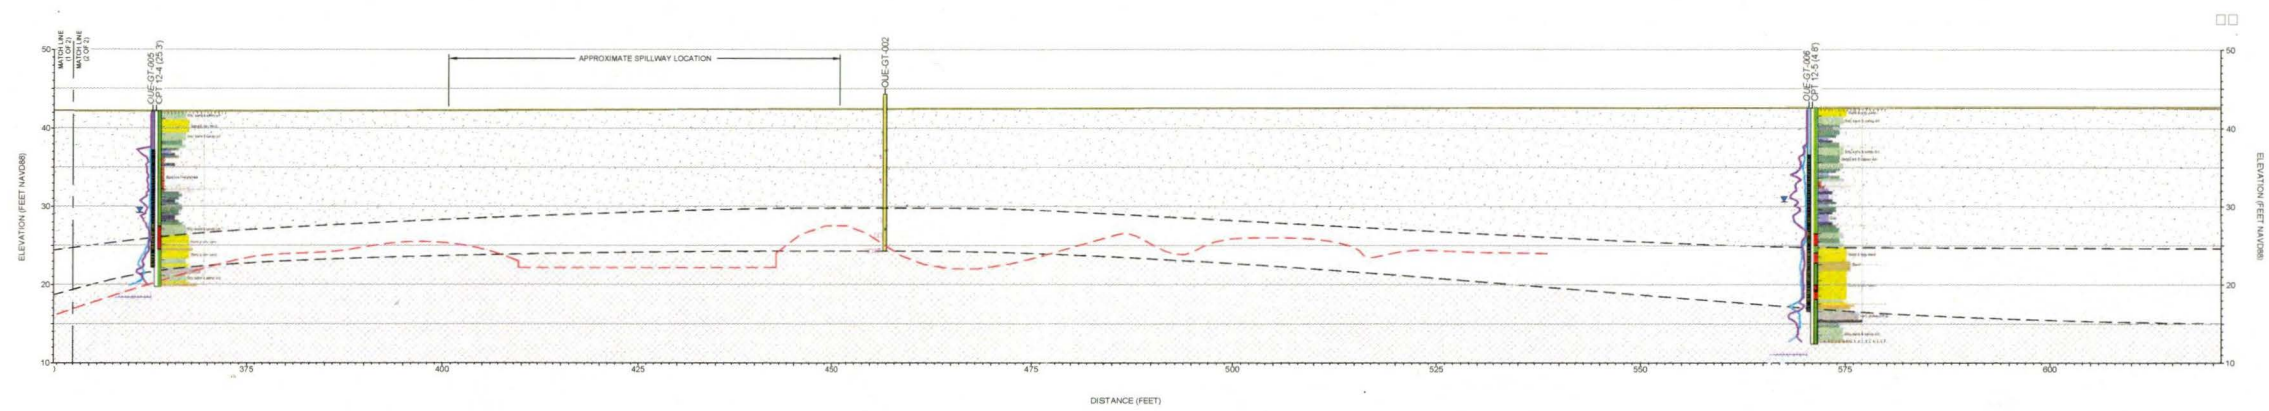
**GEOLOGIC CROSS SECTION H-H'
 CRIB WALL AND SPILLWAY**

- Geologic interpretation
 - Generally consistent with previous understanding
 - Marine terrace deposit irregular and pinches out at some locations
 - Fill at toe of embankment relatively thick, contains debris, and saturated
 - Significant amount of sediment behind dam
- Crib wall
 - Relatively well-defined parallel to dam axis
 - Built across former stream channel (Alder Creek)
 - Geophysics and observations indicate cribs span drainage and “socketed” into bedrock
- Spillway
 - Top of bedrock approximately 10 ft below spillway crest
- Log deck will provide on-site source of borrow material if needed

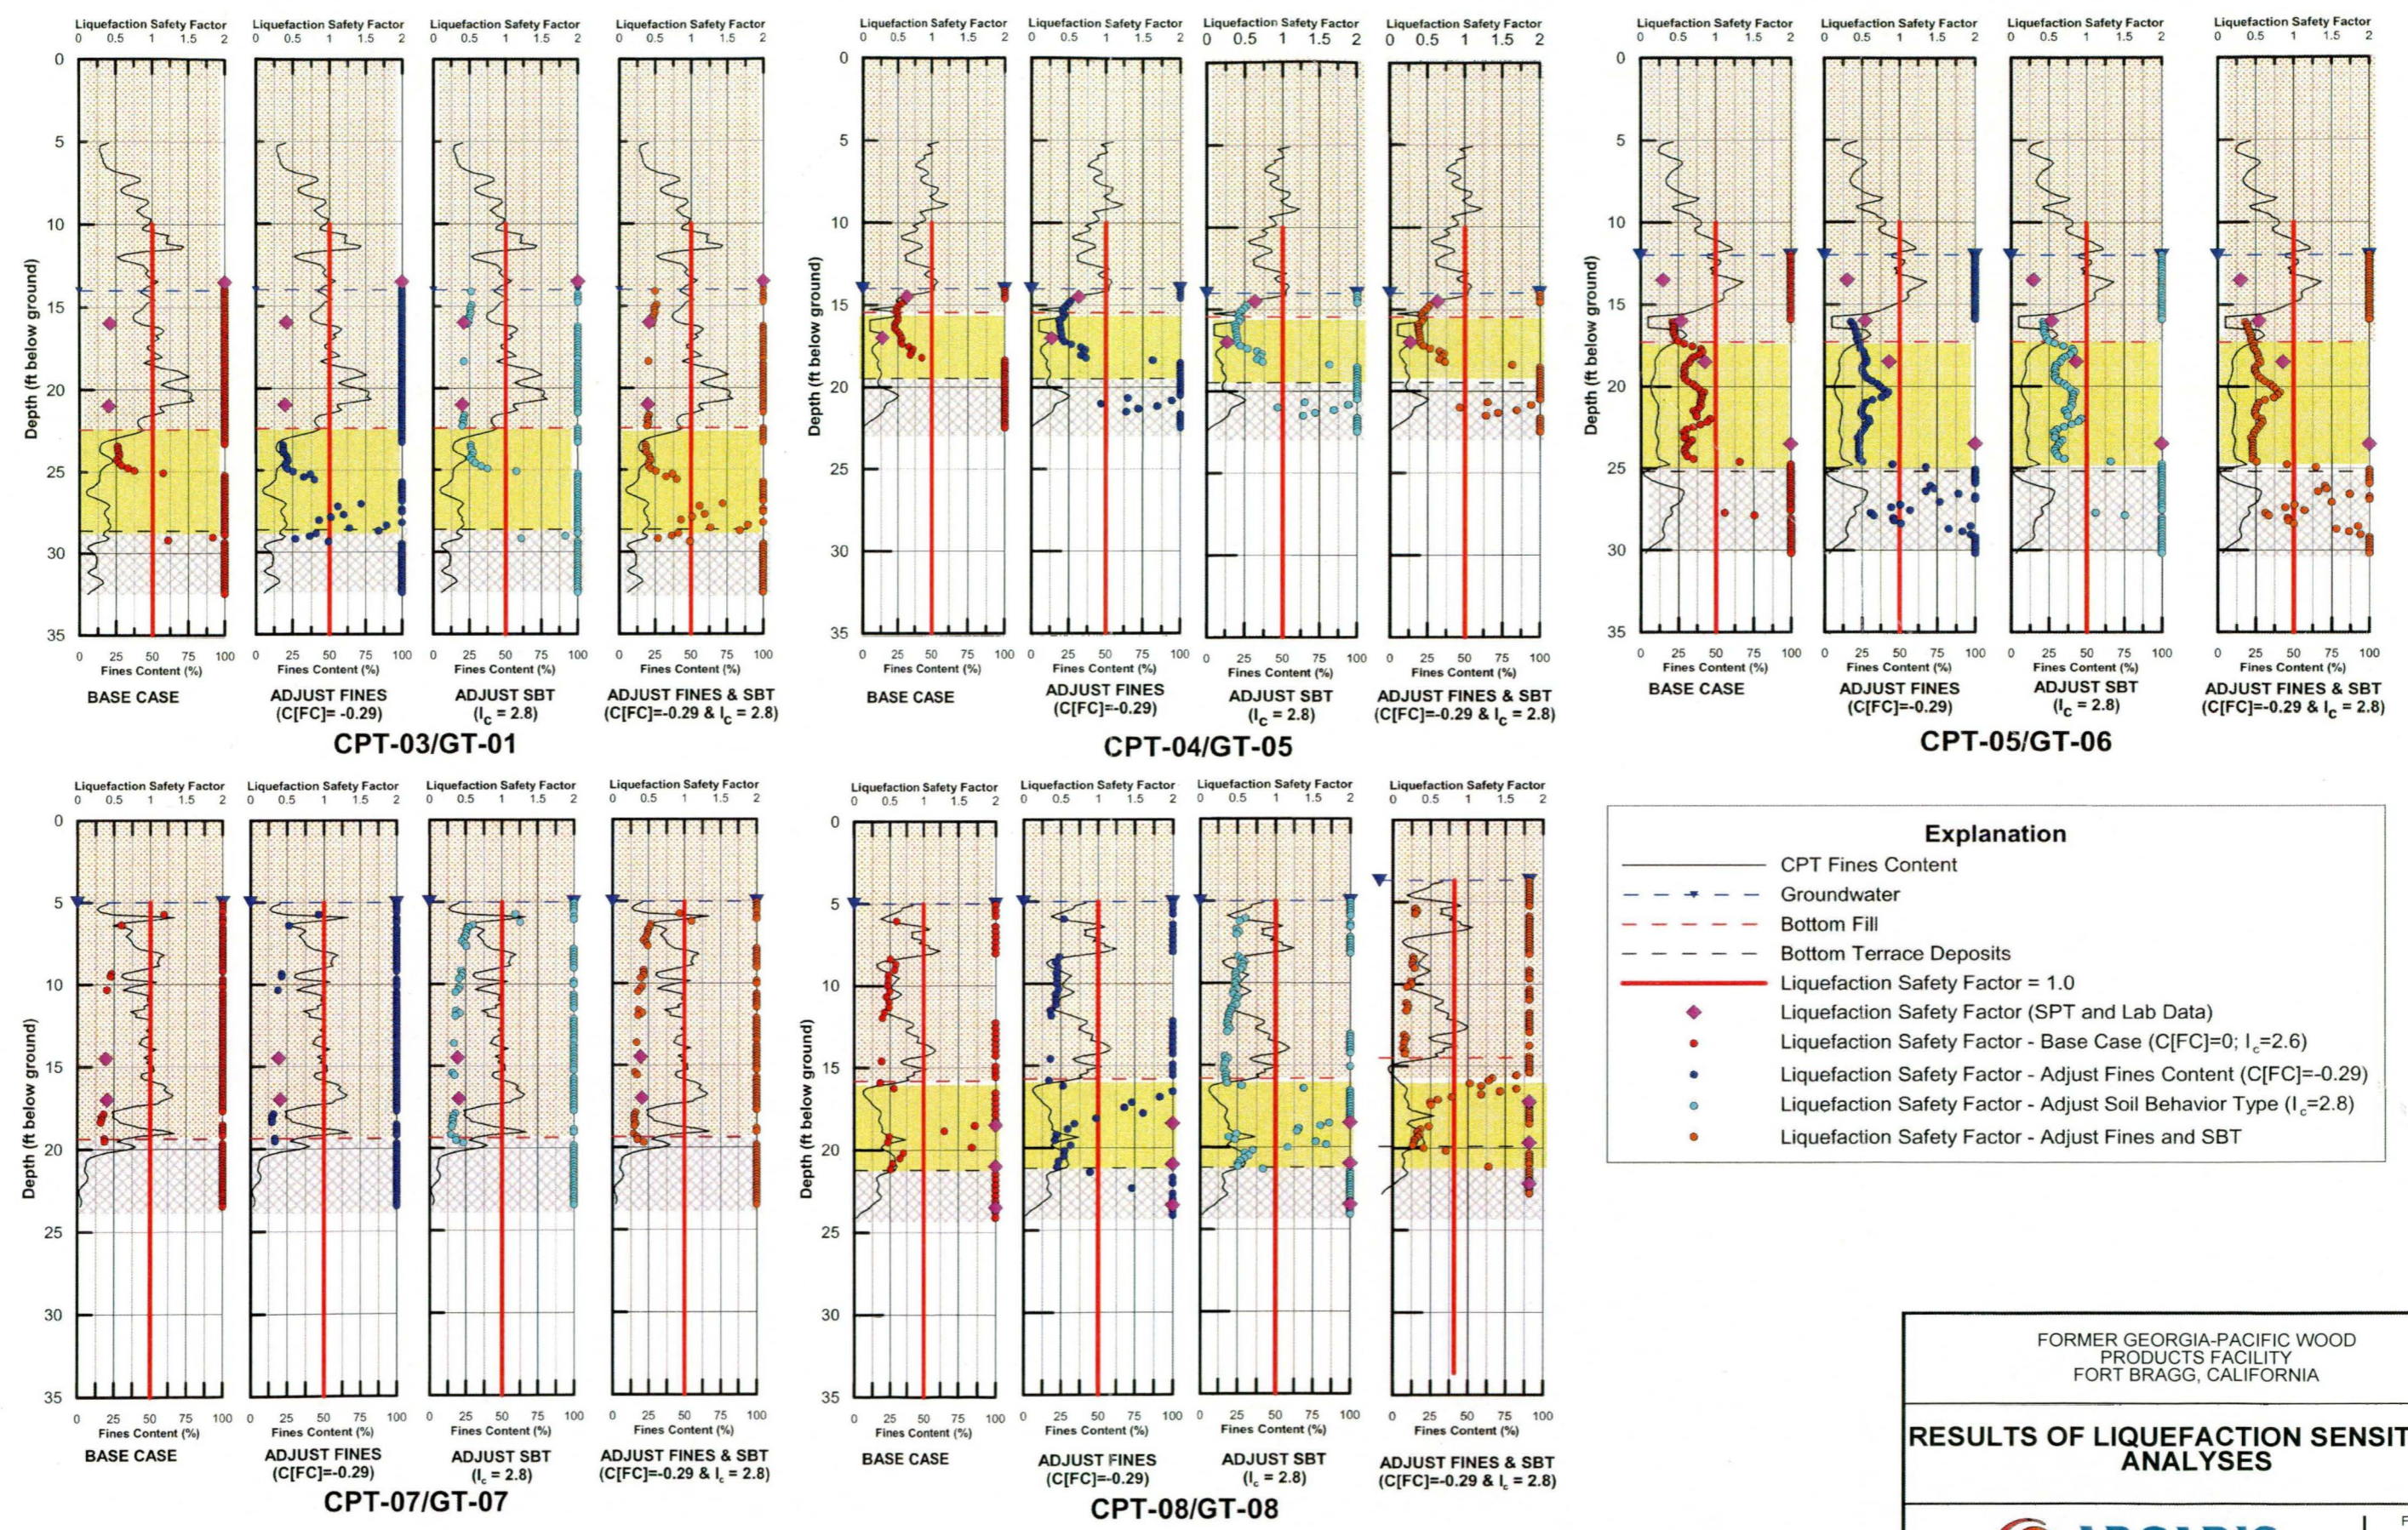
FIGURE
13

- Sensitivity
 - No reasonable variation in methods, parameters, or properties makes liquefaction “go away”
 - No reasonable variation in methods, parameters, or properties significantly changes the interpretation of liquefaction susceptibility
 - Age effect in marine terrace deposit – not significant unless factor is greater than 2.5
- Liquefaction less pervasive than original interpretation
- Generally occurs as discontinuous layers in fill and marine terrace deposits
- Fill liquefaction susceptibility variable from south (less susceptible) to north (more susceptible)
- Marine terrace deposits variably susceptible to liquefaction (including deposits underlying fill downstream of dam)

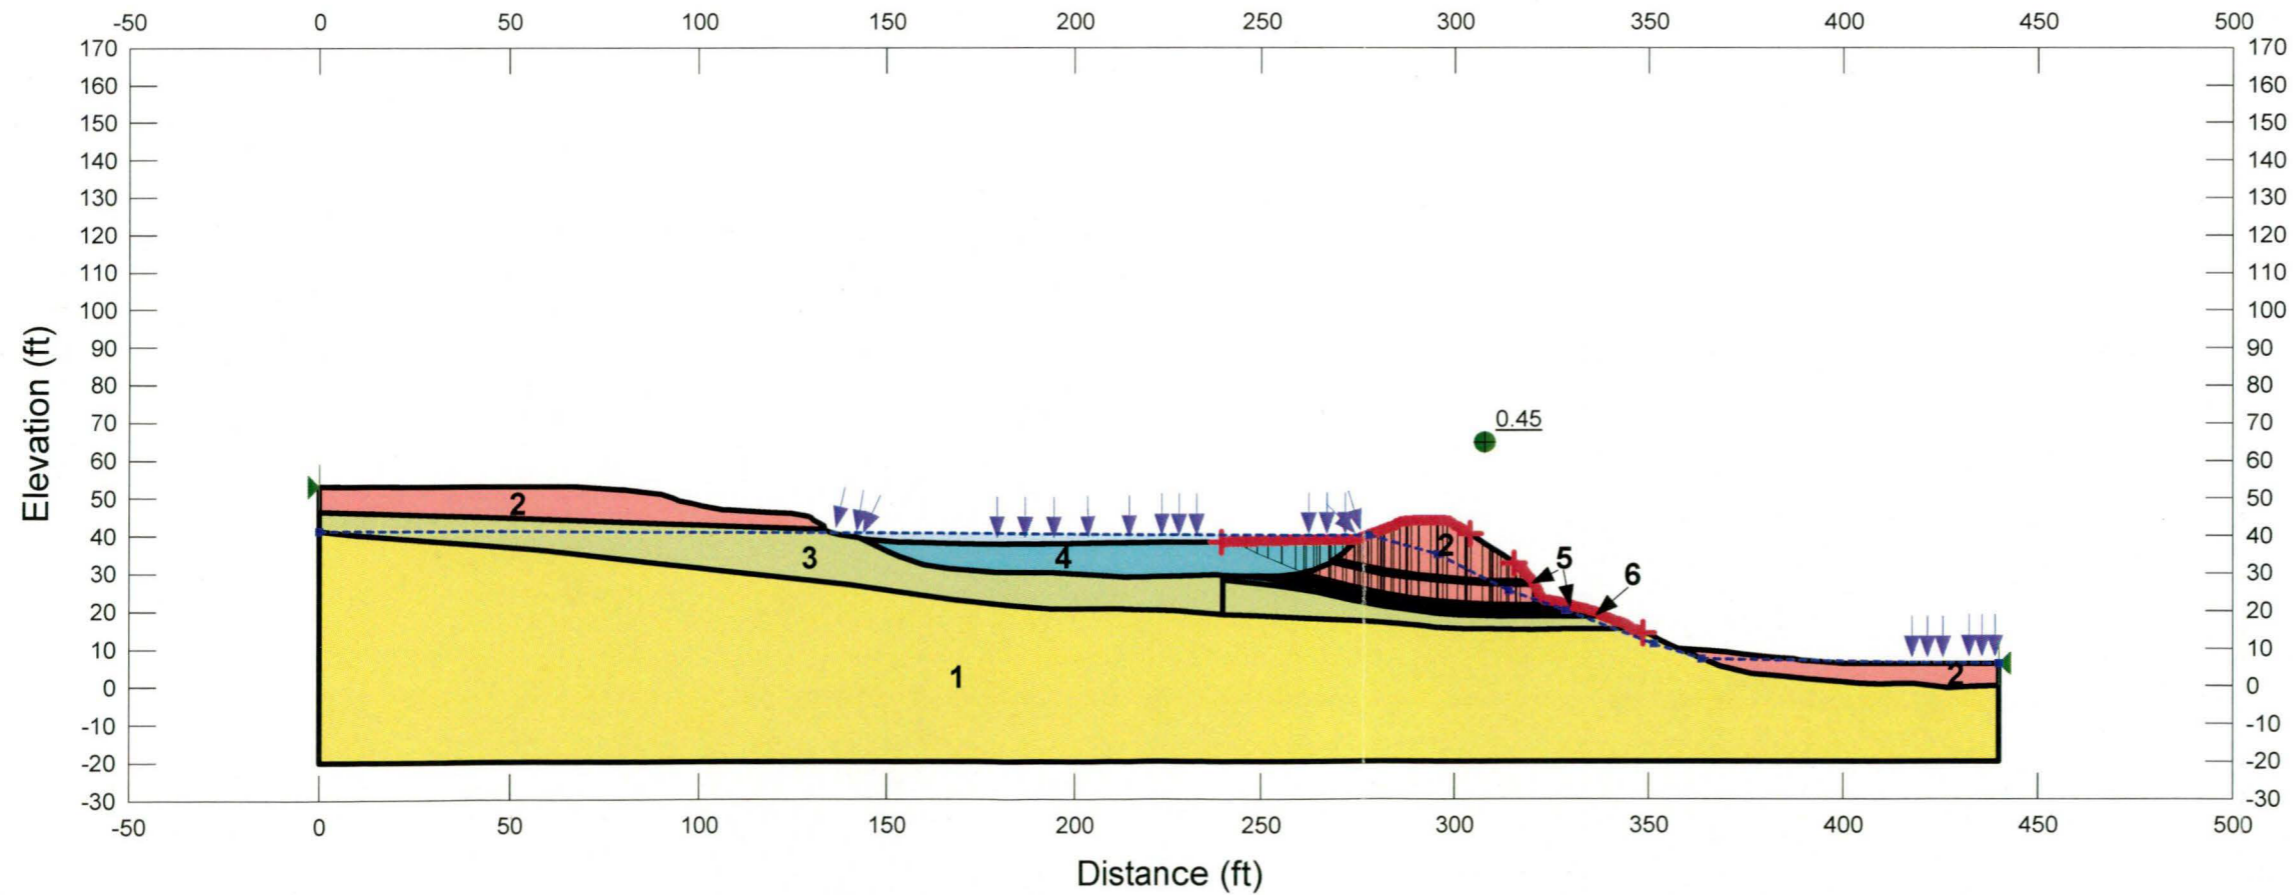
Attachment 1
Figure 7

- With no liquefaction:
 - Static stability generally acceptable if crib wall not neglected in analysis
 - Seismic deformation less than 6 inches
- With liquefaction assumed:
 - Back-sliding into the sediment and water behind the dam not significant
 - Mitigation of crib wall and northern sections still warranted
 - Mitigation of central section not necessary due to width of section
