Stability Assessment of the Mill
Pond Dam

Former Georgia-Pacific Wood Products Facility
Fort Bragg, California

June 2010

Prepared for:
Georgia-Pacific LLC

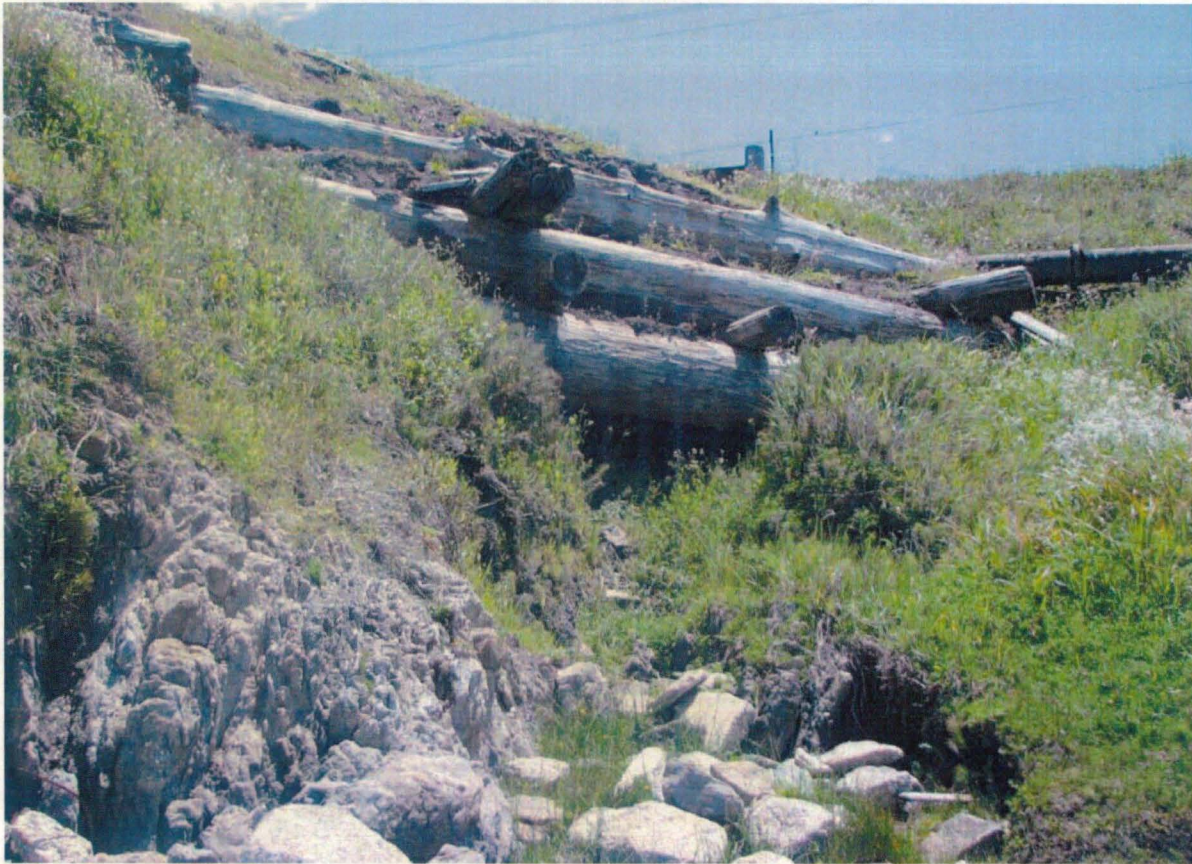
The timber-cribbing wall to the left of the spillway remains in very poor condition and continues to deteriorate. Embankment material continues to be transported from behind the wall, opening voids and causing a loss of contact and support between the structural timbers and the supported embankment.

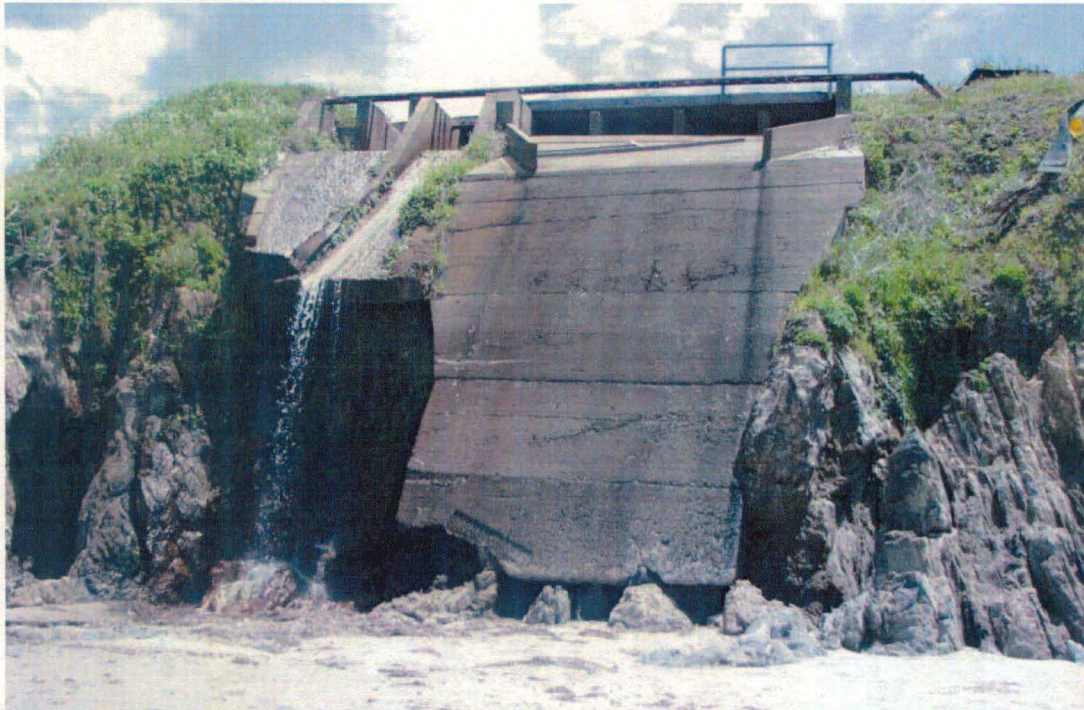
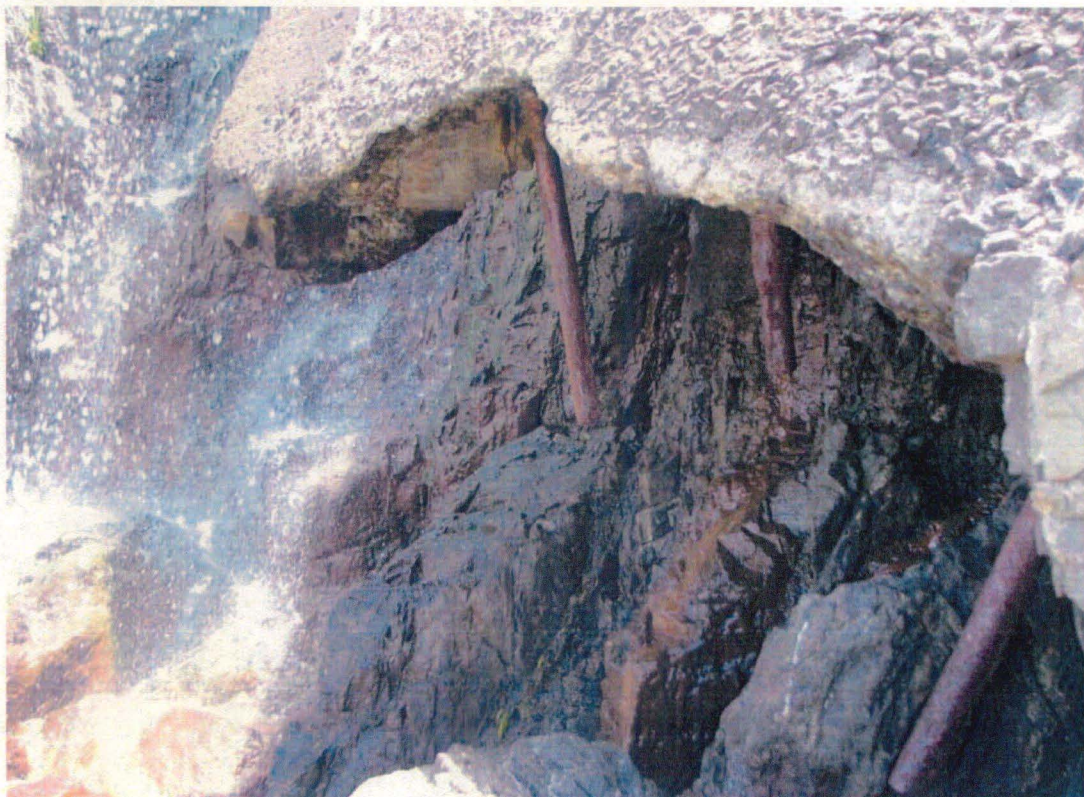
The concrete spillway (top photograph, above) is also deteriorating, and rebar is exposed beneath and behind the concrete facing (bottom photograph, below).

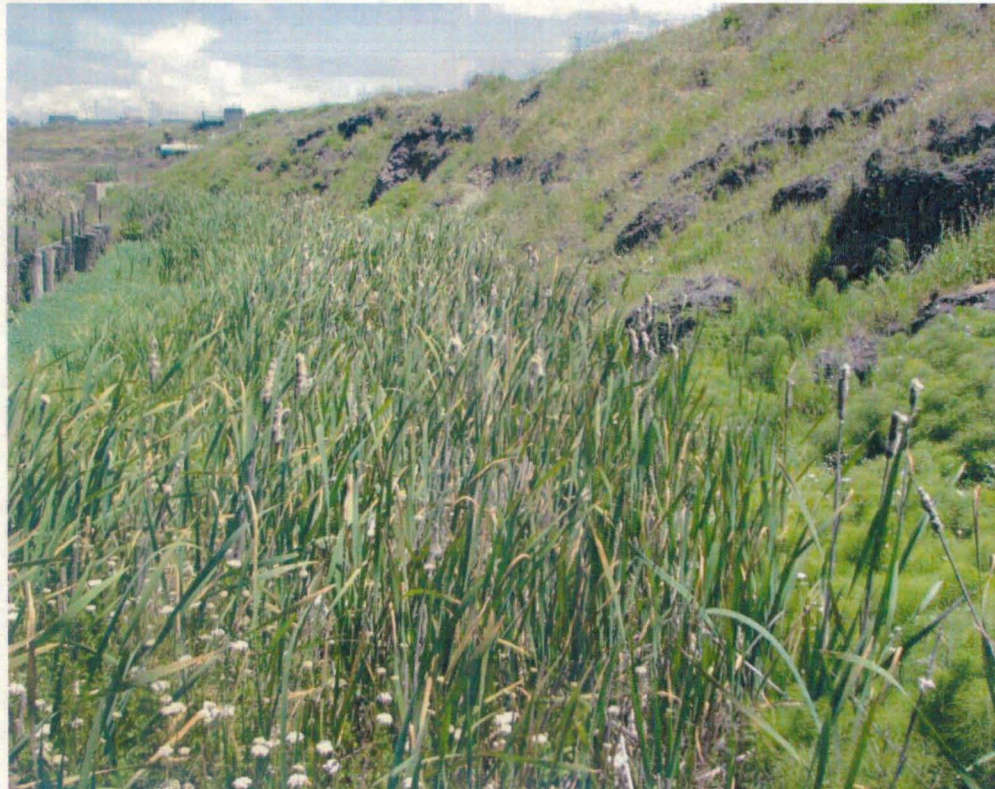
Standing water occupies the downstream toe of the right embankment at the former location of a water treatment plant (bottom photograph, above). While several supply and feed pipes from the facility are known to perforate the embankment in this area, neither the condition of the pipe nor the status of pipe encasements is known. It appears likely that seepage from, or around, the pipes are a likely source of the seepage observed.

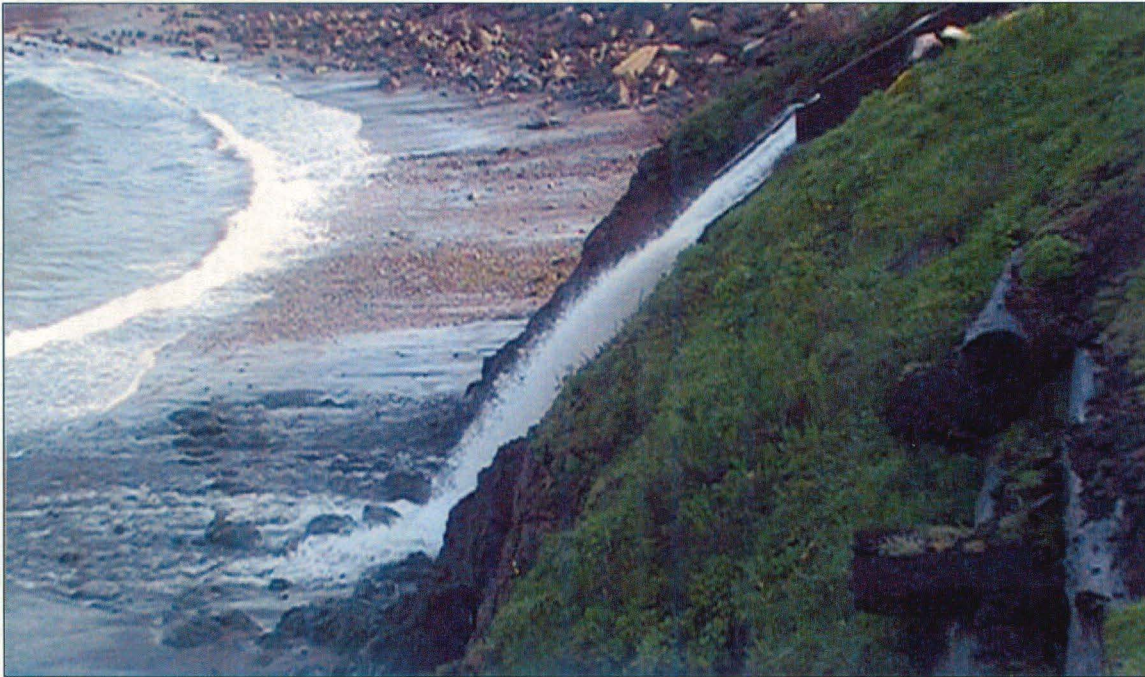
View of the western wall including the spillway and the cribwall showing beach erosion and shoreline loss

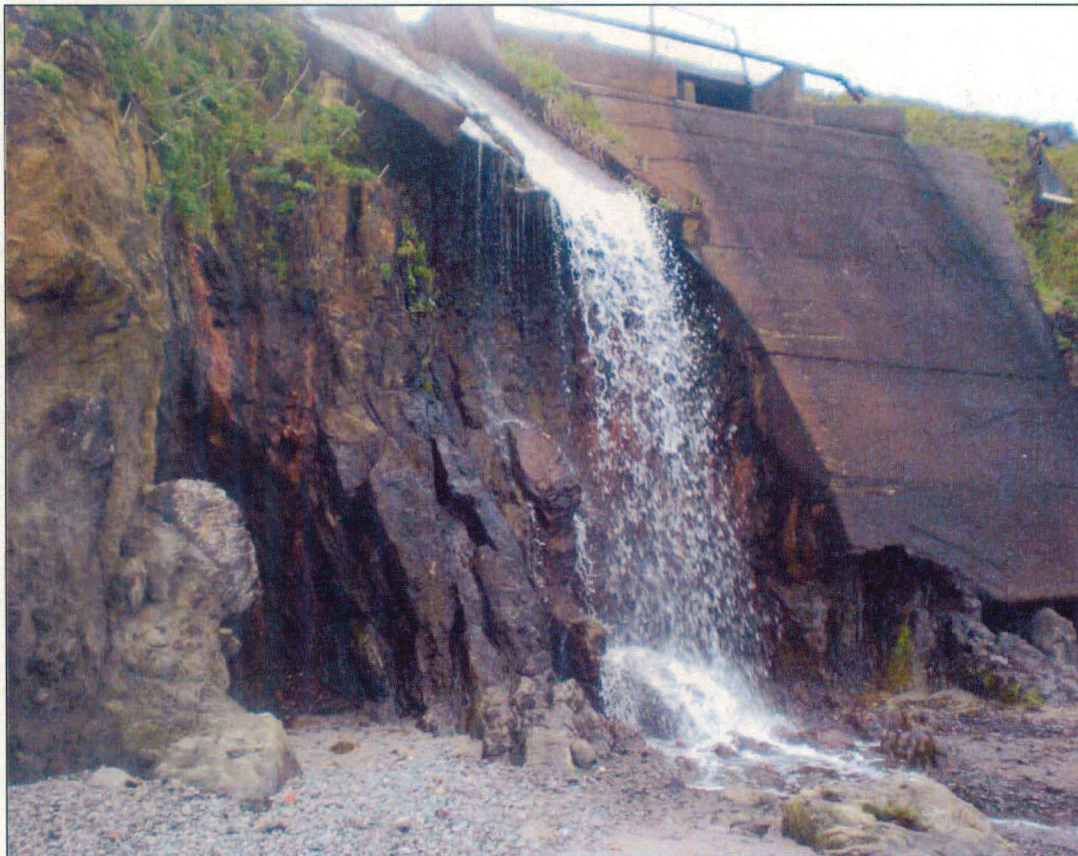
View of the cribwall and the spillway discharging directly on the beach

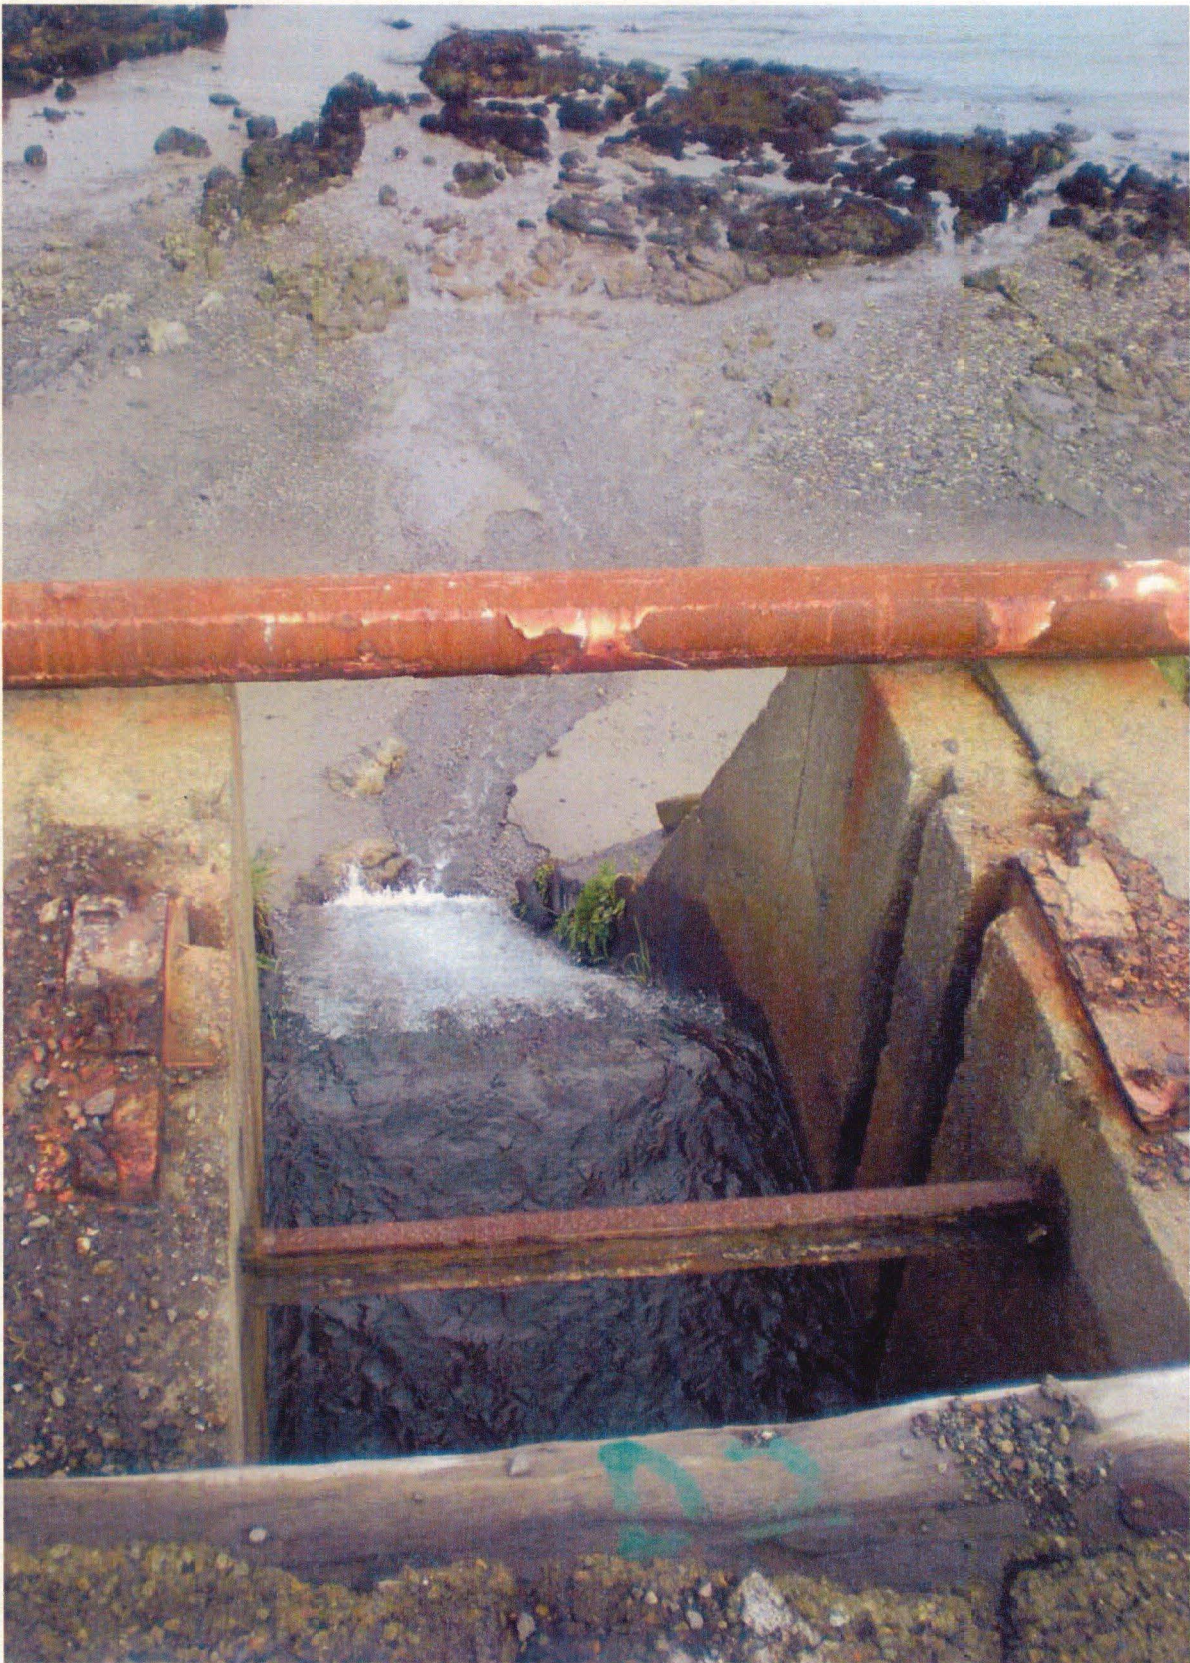
Spillway showing beach erosion and damage to the spillway concrete flow structure

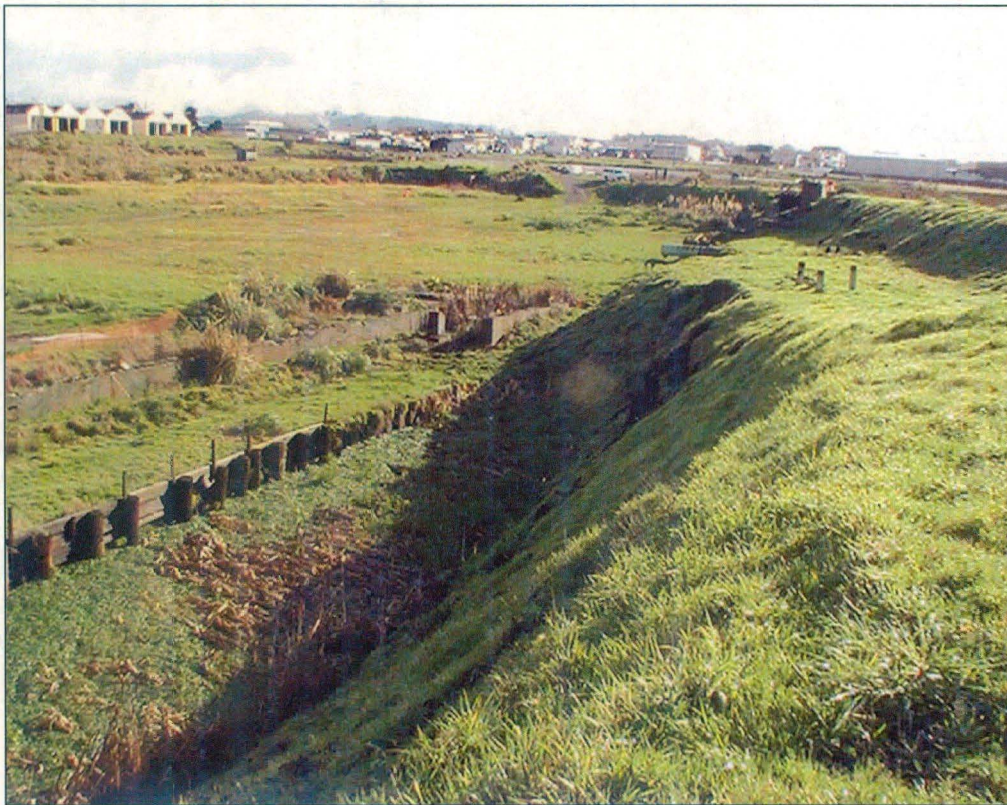
View of the oversteepened slope of the northern dam wall above Pond 7

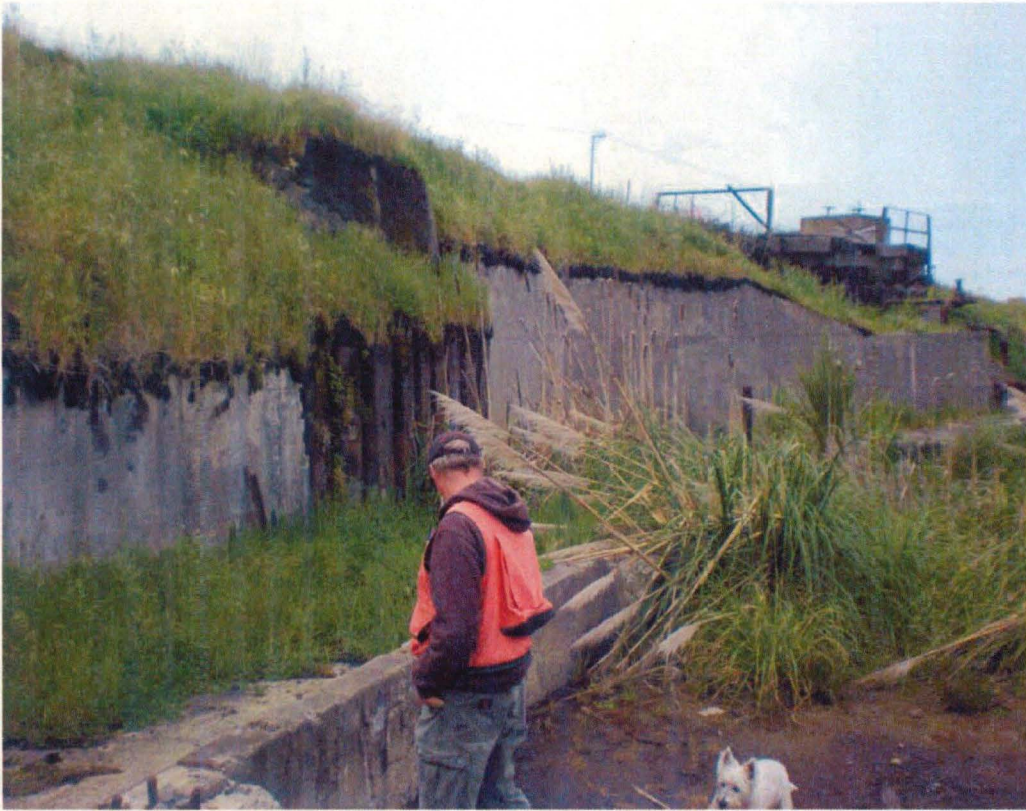
Eroding concrete retaining wall along the north wall showing extensive leakage
