# Department of Toxic Substances Control
# Site Visit Report

| **Site/Project Name:** | Georgia-Pacific Corporation |
| **Purpose of Visit:** | To inspect and document the condition of the fencing around Pond 8 to prevent unauthorized access; Pond 8 access must be restricted by a fence per the by the 2022 First Order Amendment for the site. |

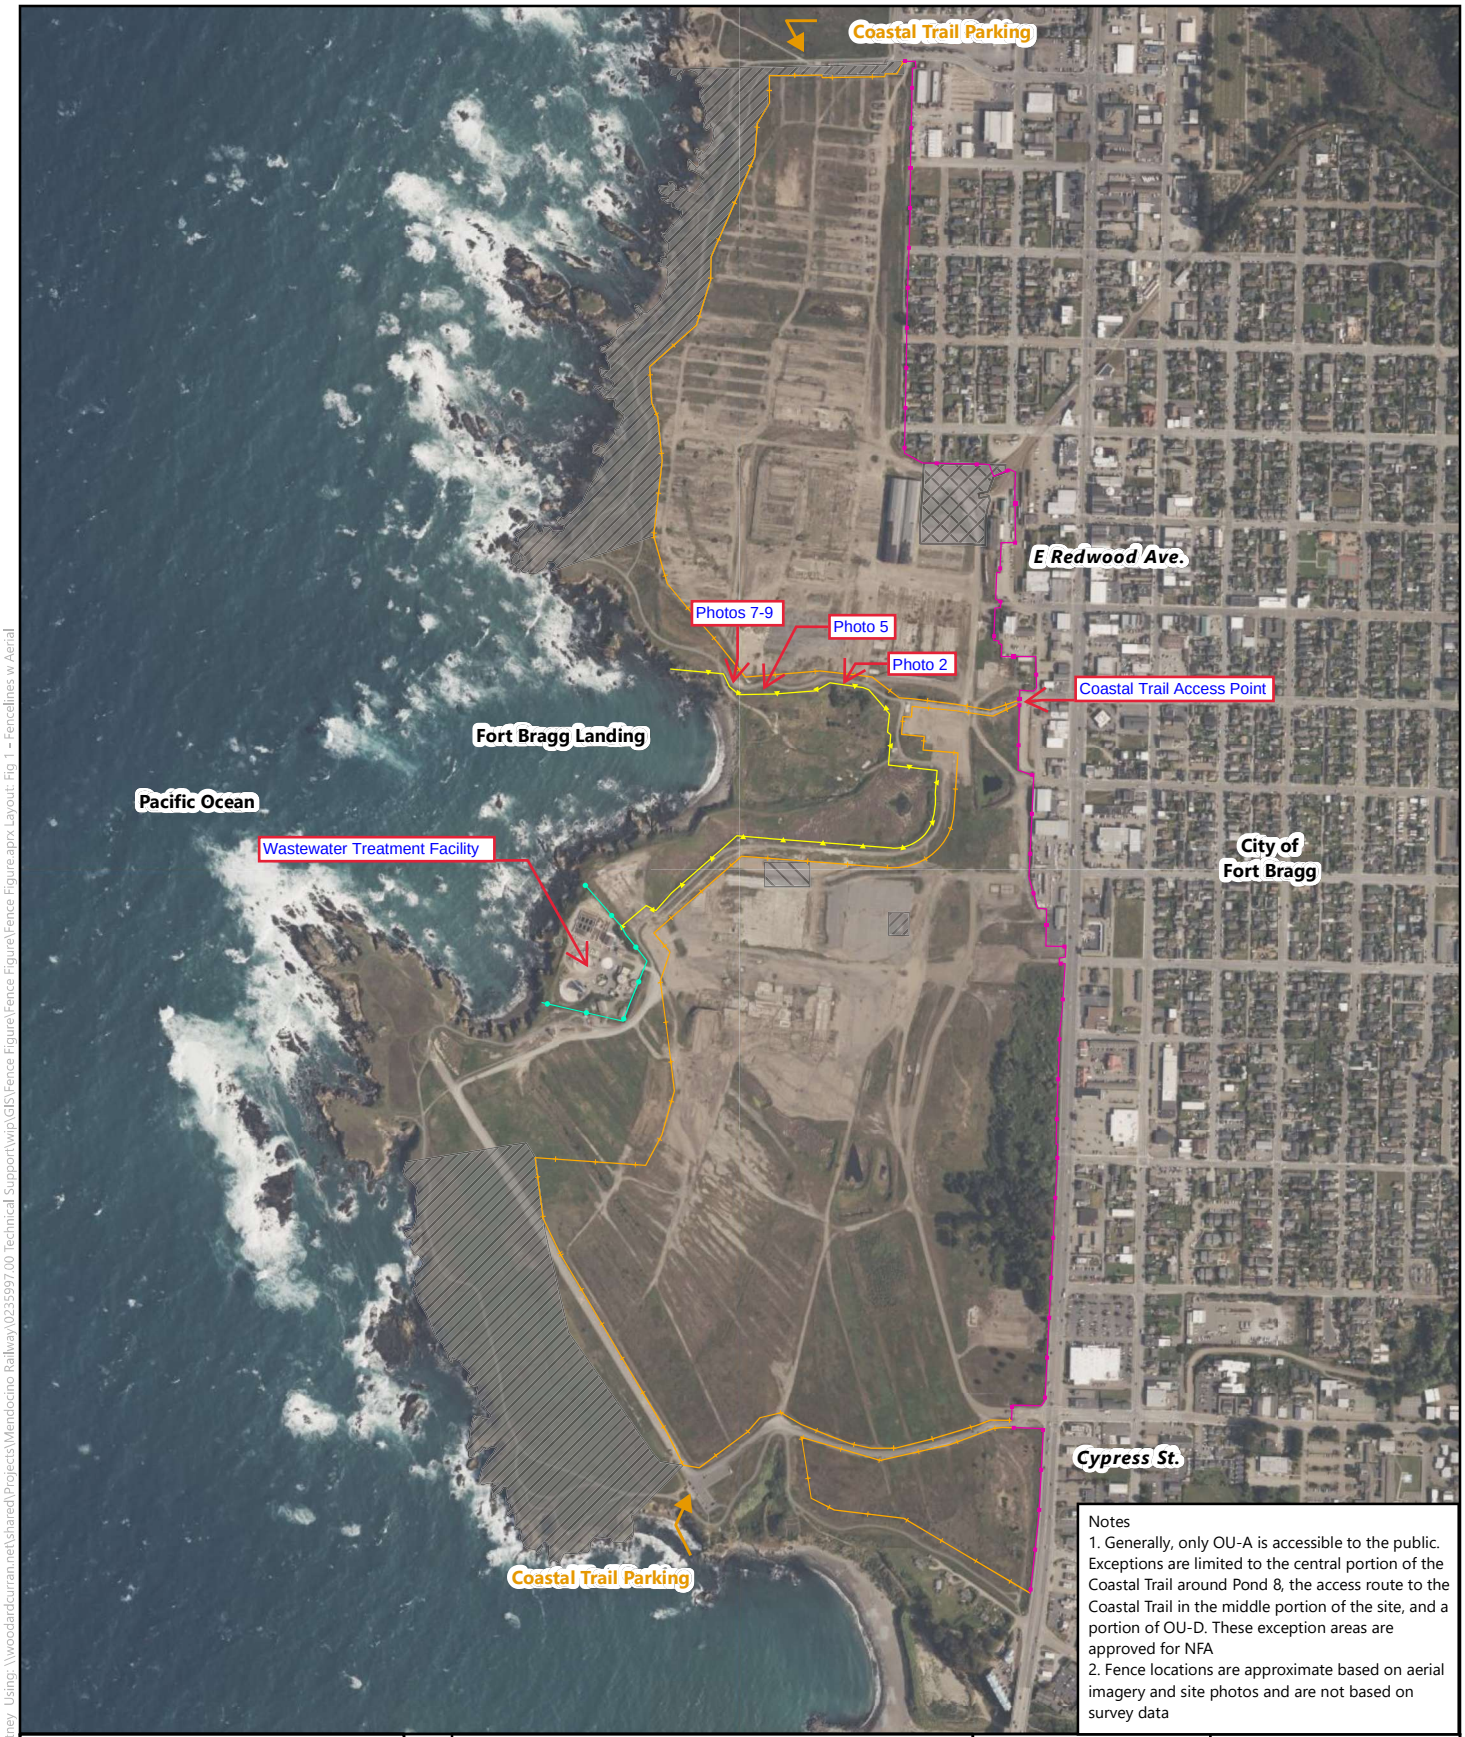
**Figure 2**

In areas where the fence is not readily accessible due to dense vegetation, fencing is often intact and upright. In some of the more accessible areas, panels appear to have been repaired (see Photos 2, 5, and 6 for example). There is a complete breach of the fence in an area where the fence is below the elevation of the Coastal Trail, where one can access the full fence panels and cut them to gain access to a beach that is otherwise inaccessible to the public. See the attached photos and Figures 1 and 2 attached to this report; Figure 2 include an electronic markup of the approximate locations of select photos.
