The Resources Agency
DEPARTMENT OF WATER RESOURCES
Division of Safety of Dams

Memorandum of Conference

Mill Pond Dam and Reservoir, No. 2381
Mendocino County
March 17, 2015

Georgia-Pacific Mill Pond Dam Project Update

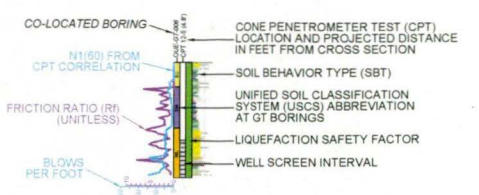
**GEOLOGIC CROSS SECTION H-H'
 CRIB WALL AND SPILLWAY**

- Liquefaction of upper several feet of marine terrace deposits
 - Entire dam seismically unstable
- Assumptions guiding conceptual mitigation
 - Crib wall section probably need to be removed and replaced

- Objectives:
 - Stabilize northern section and central section (if necessary) with earthfill buttress
 - Replace spillway due to uncertain foundation conditions
 - Replace crib wall section with concrete gravity structure due to uncertain foundation and construction conditions
- Concepts remain valid
- Northern buttress:
 - Foundation/key deeper than originally estimated due to fill thickness
 - Water inflow and management during construction
- Crib wall excavation and replacement
 - Crib wider (~70 ft) than initial estimates (~40 ft)
 - Overall dimension of replacement structure similar
 - Irregular bedrock surface – increased foundation preparation costs
 - Construction challenges and constraints due to location

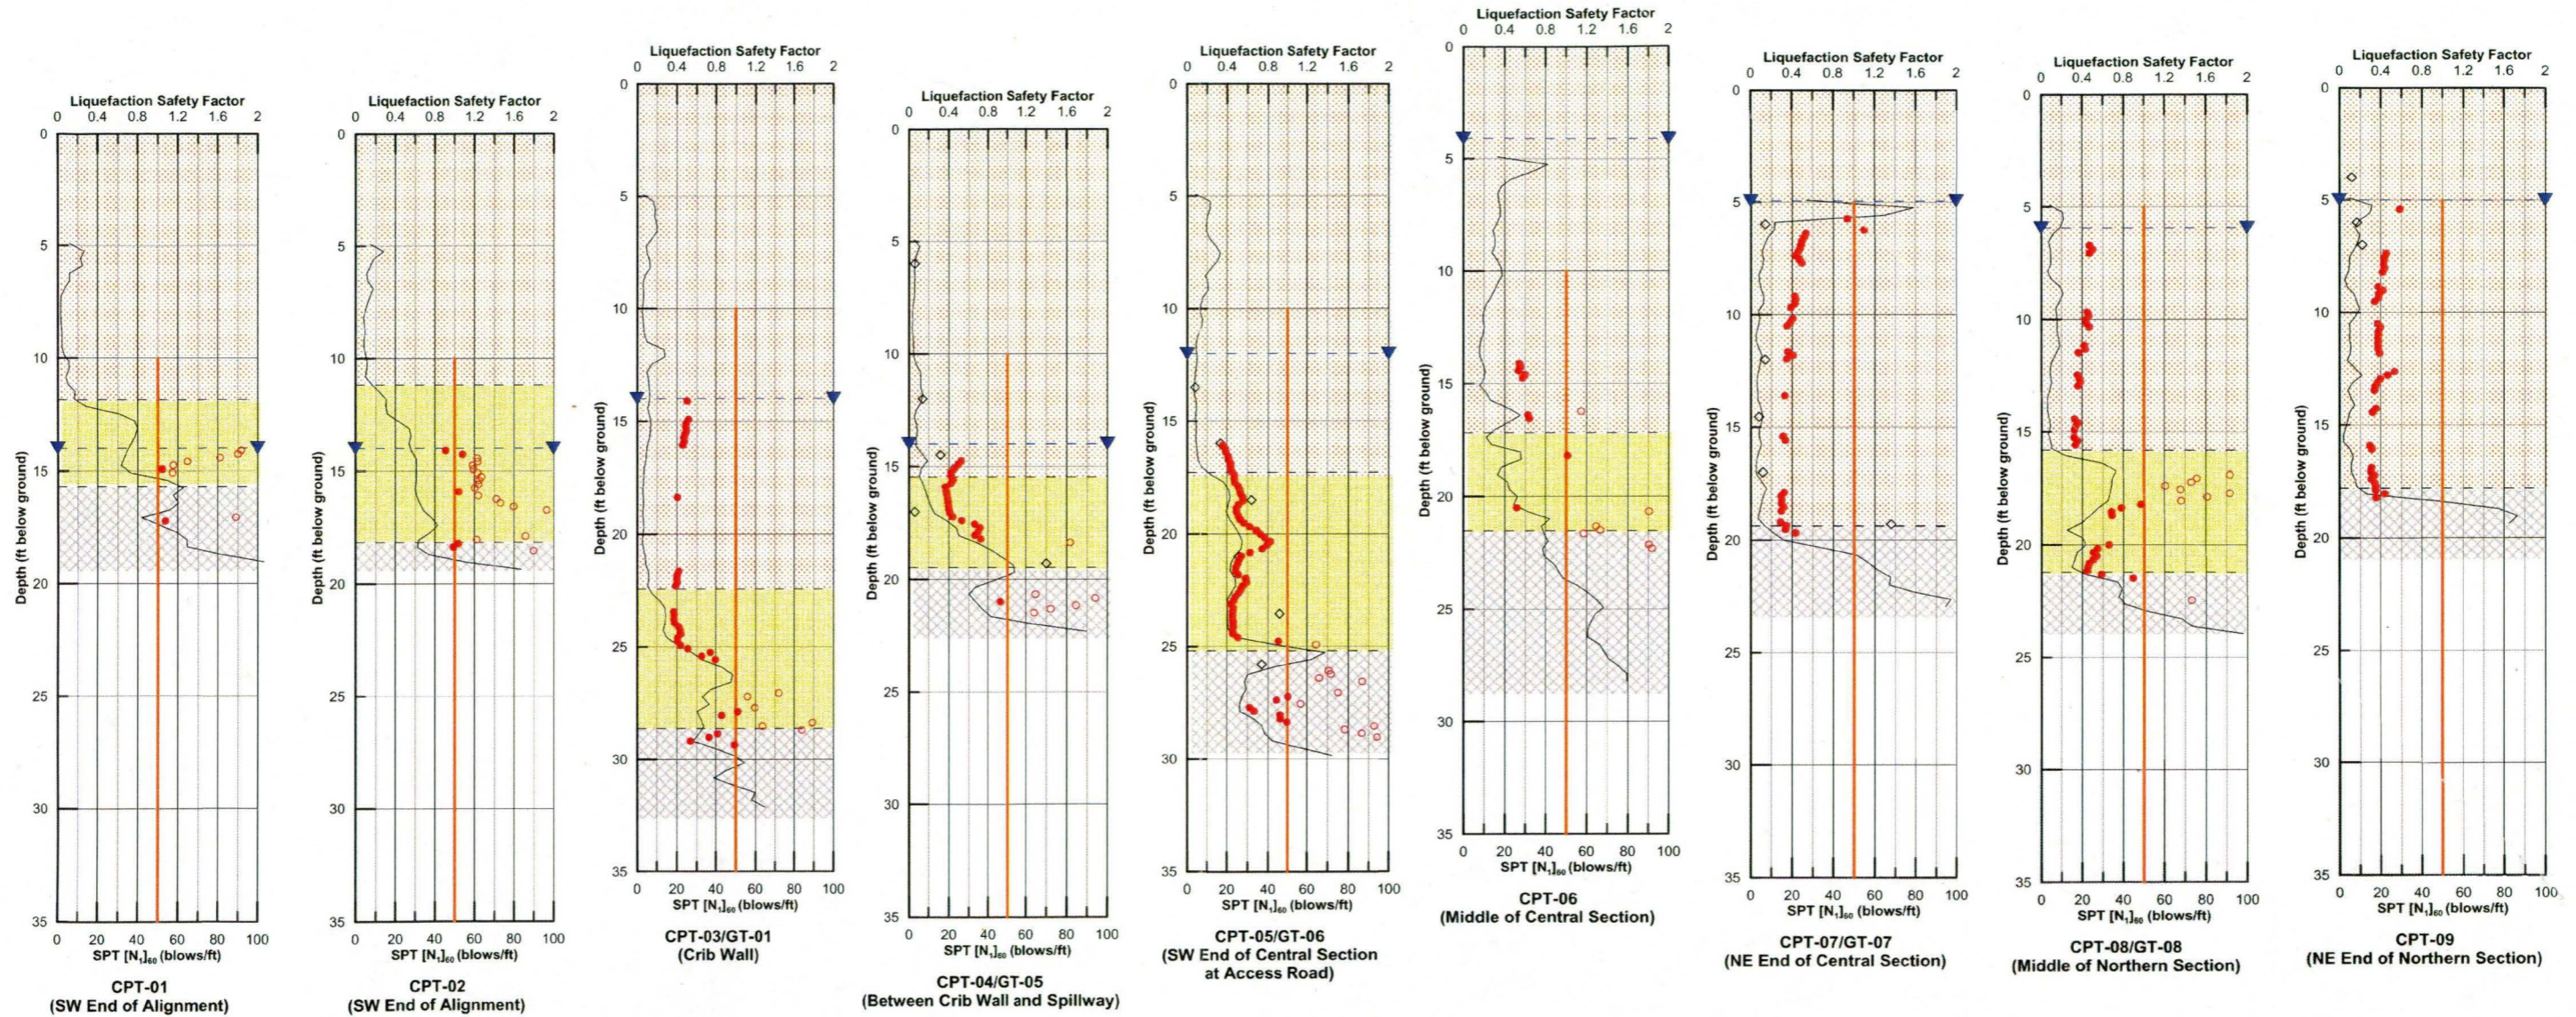
FIGURE
13

- Figure 13 (Sensitivity Analysis)
- Figure 14 (Liquefaction Profile)
- Figure 15 (Liquefaction Crib Wall Section)
- Figure 16 (Liquefaction Central & Northern Section)
