Stability Assessment of the Mill
Pond Dam

Former Georgia-Pacific Wood Products Facility
Fort Bragg, California

June 2010

Prepared for:
Georgia-Pacific LLC

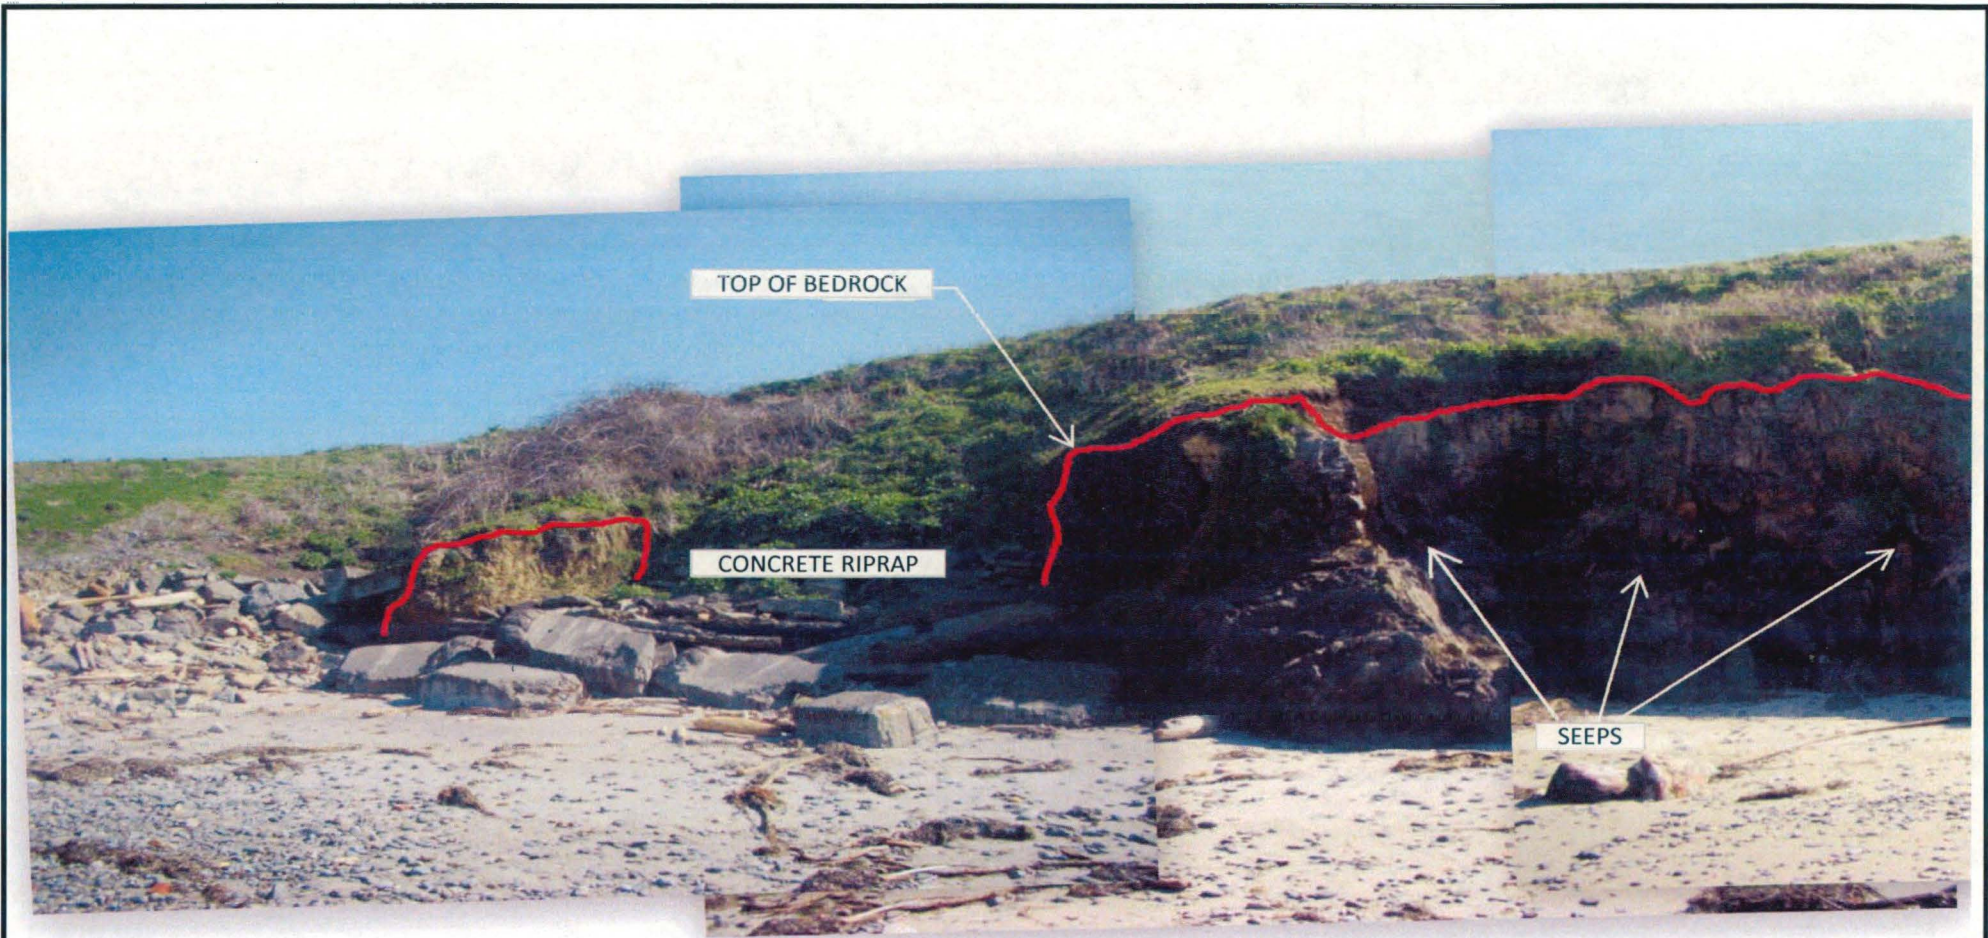
FIGURE
A-6

NOTES:
 PHOTOS WERE TAKEN FROM SOLDIER BAY BEACH, JUST TO THE EAST OF
 SECTION D-D' (REFER TO FIGURE 3 OF THE REPORT).

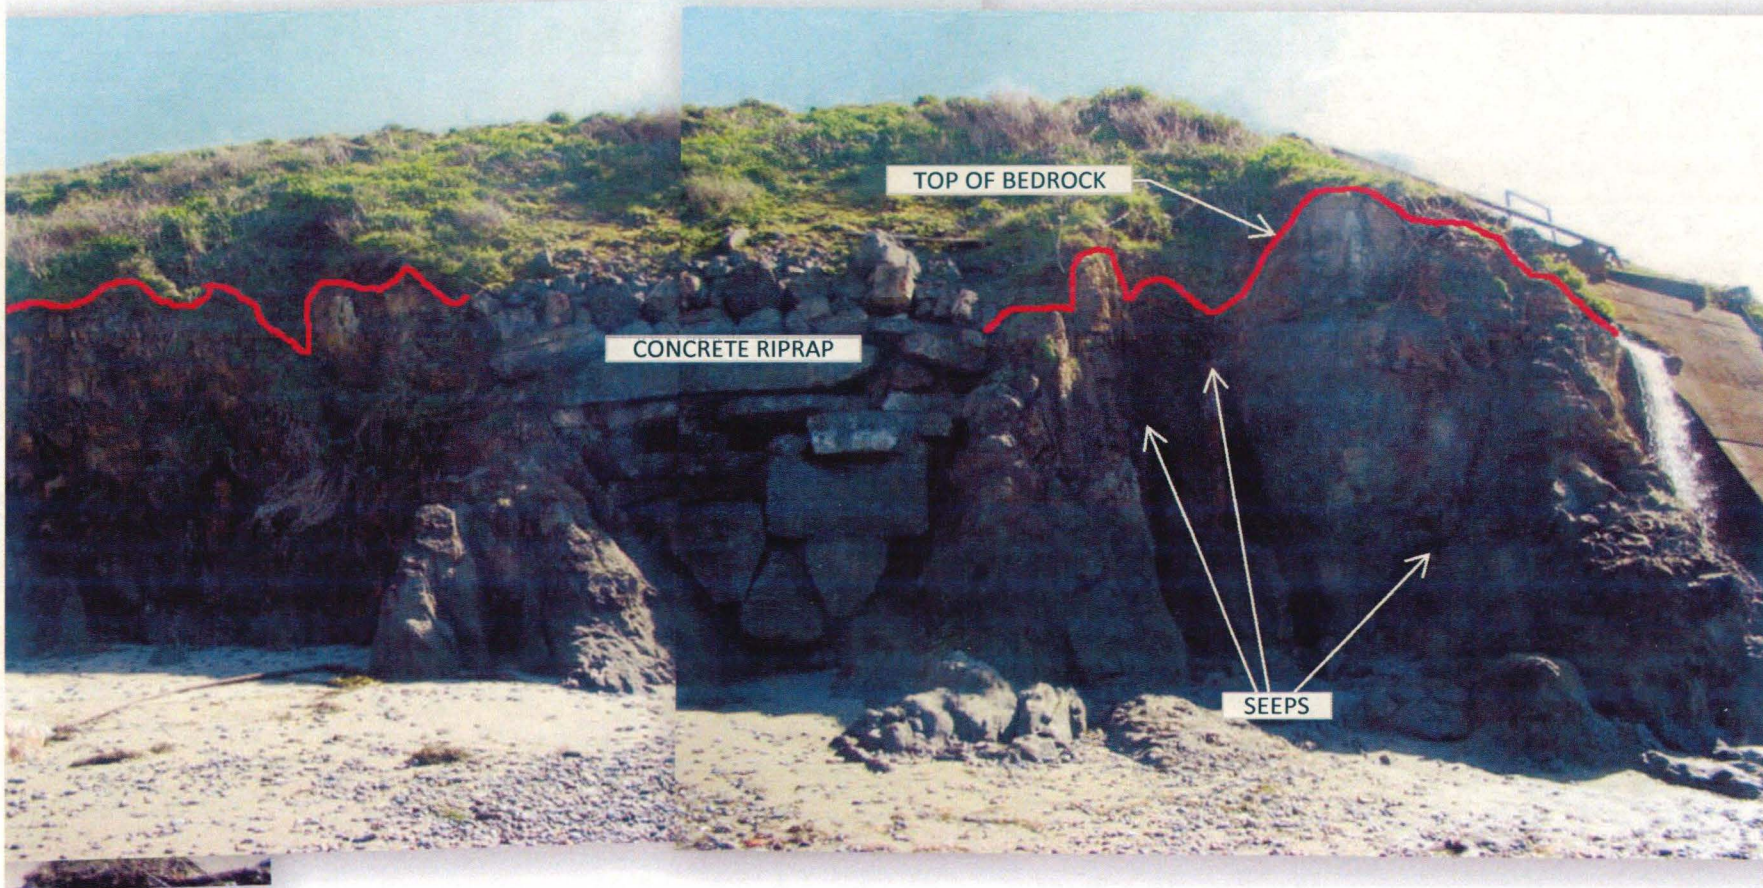
FIGURE
A-7

NOTES:
 PHOTOS WERE TAKEN FROM SOLDIER BAY BEACH, NEAR SECTION D-D'
 (REFER TO FIGURE 3 OF THE REPORT).

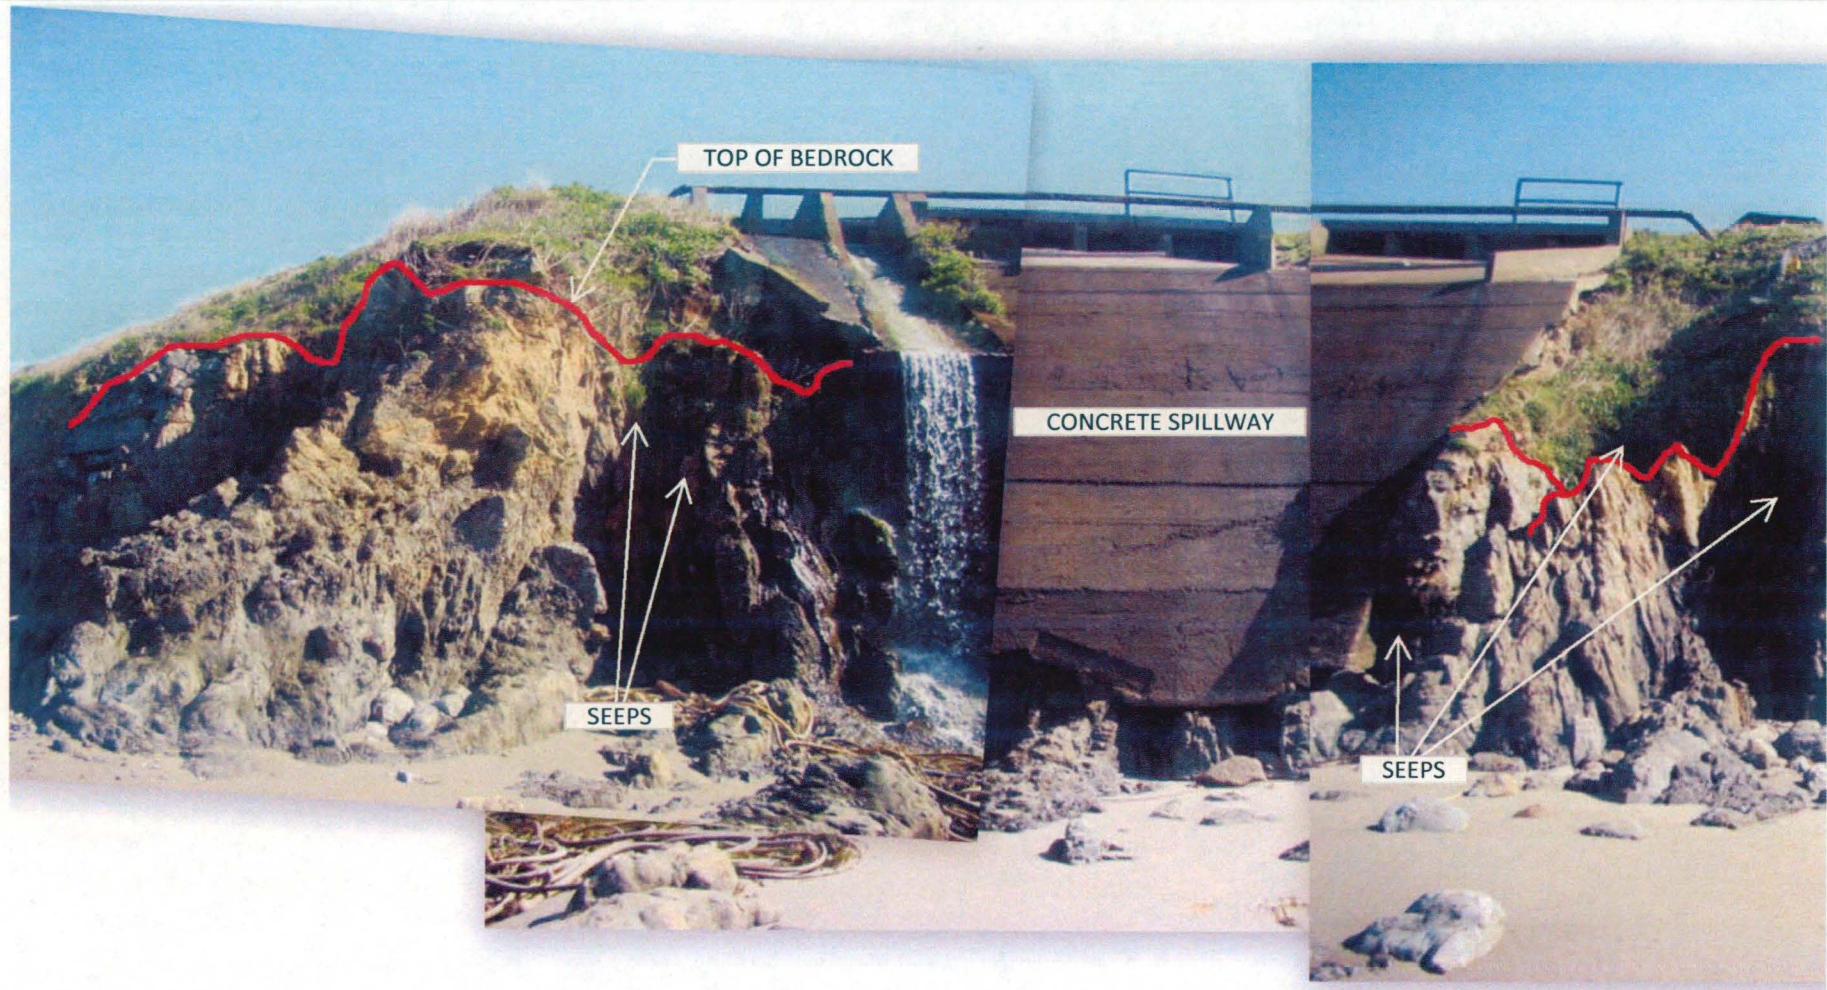
FIGURE
A-8

- erosion along the toe of the concrete spillway;
- soil has loosened and eroded from the cribwall;
- seepage on the north wall and dam face could lead to failure by piping (internal erosion) ; and
- the dam is more than 100 years old and susceptible to earthquakes (DSOD, 2009).

NOTES:
 PHOTOS WERE TAKEN FROM SOLDIER BAY BEACH, NEAR SECTION C-C'
 AND THE SPILLWAY (REFER TO FIGURE 3 OF THE REPORT).

1. Fill the large void at the timber supported portion of the embankment (cribwall)
2. Patch the damaged base of the spillway structure (spillway)
3. Remove tule growth along the toe the right embankment (northern dam wall)
4. Clear the brush that obstructs embankment, groins and abutments

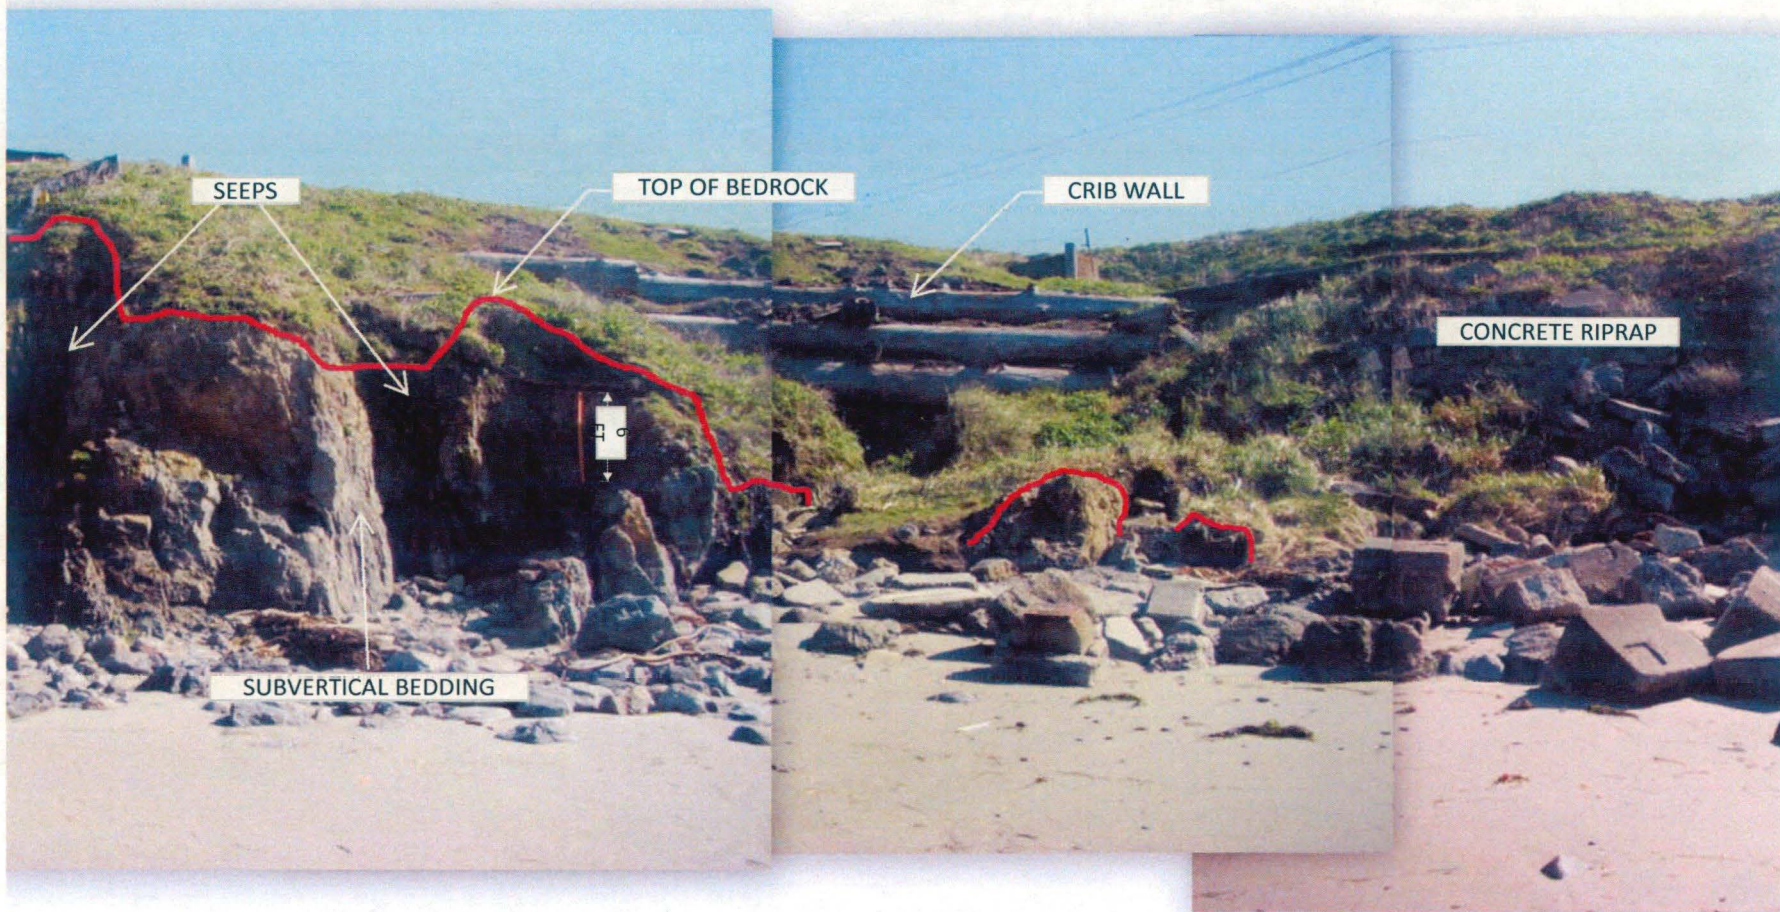
The most critical portion of the dam appears to be the area near the spillway and crib wall (Figure 3) located at cross section locations B-B' and C-C', respectively. The crib wall is also depicted on Figure 4 – Section B-B'. DSOD also noted in June 2009, relative to the North Wall of the pond, that:

NOTES:
 PHOTOS WERE TAKEN FROM SOLDIER BAY BEACH, NEAR SECTIONS A-A'
 AND B-B' AND THE CRIB WALL (REFER TO FIGURE 3 OF THE REPORT).

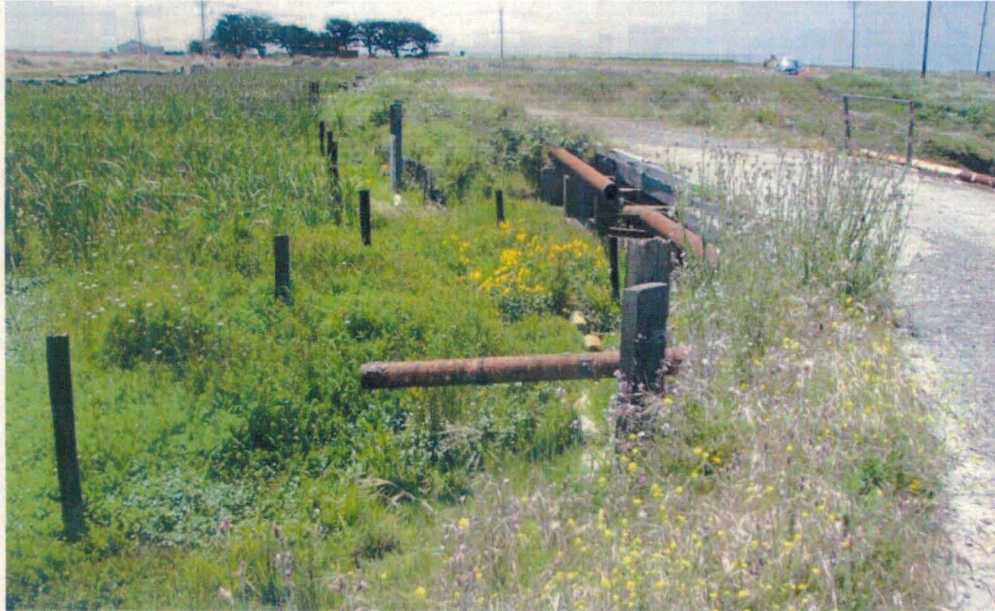
The spillway entrance is partially impeded by dense vegetation (top photograph, above). Abundant floating vegetation throughout the pond, including immediately adjacent to the spillway entrance, makes the possibility of clogging of the spillway with floating vegetation and other debris during a storm a concern.

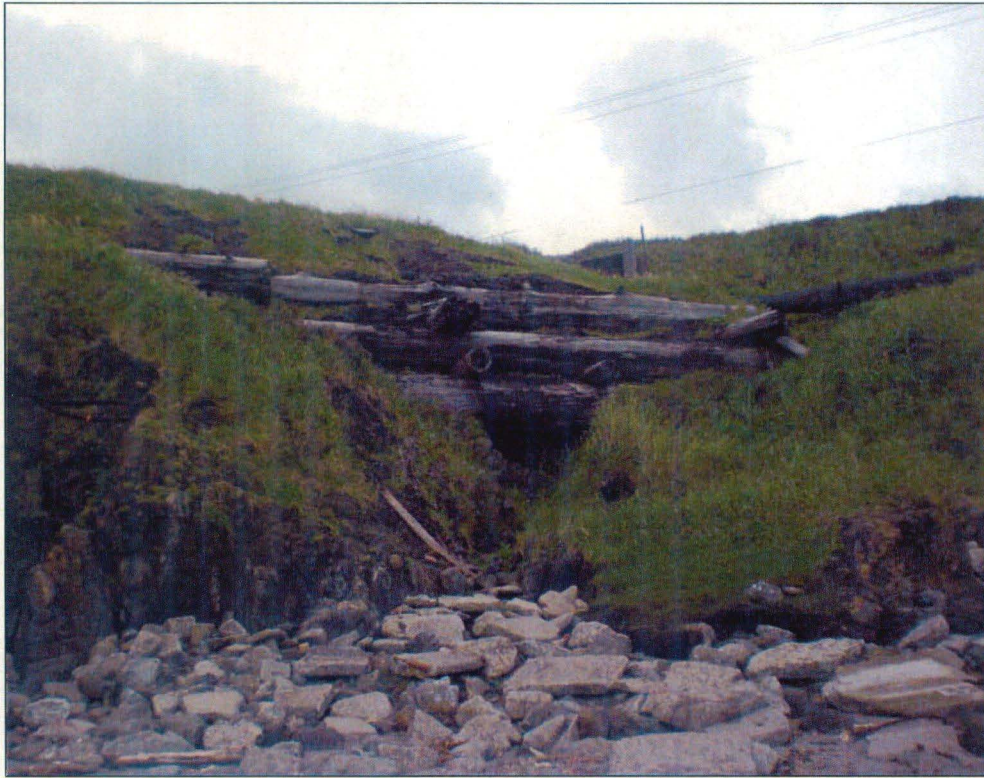
Crib wall on the western dam wall exhibiting soil loss and cavity developing amongst the cribs

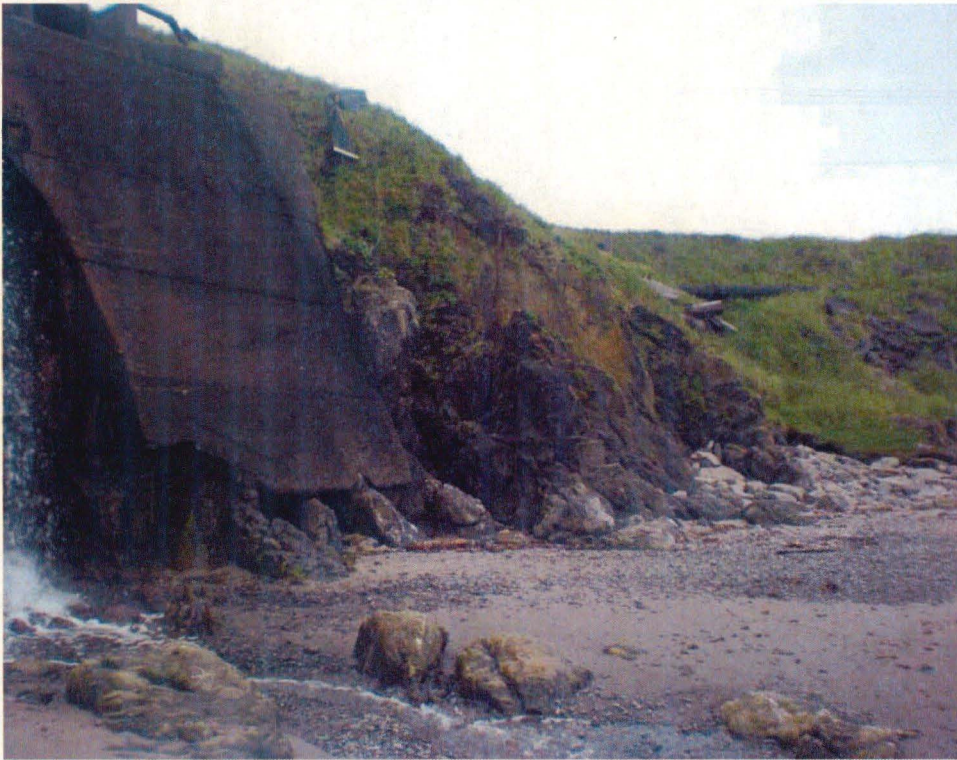
View of the western wall including the spillway and the cribwall showing beach erosion and shoreline loss

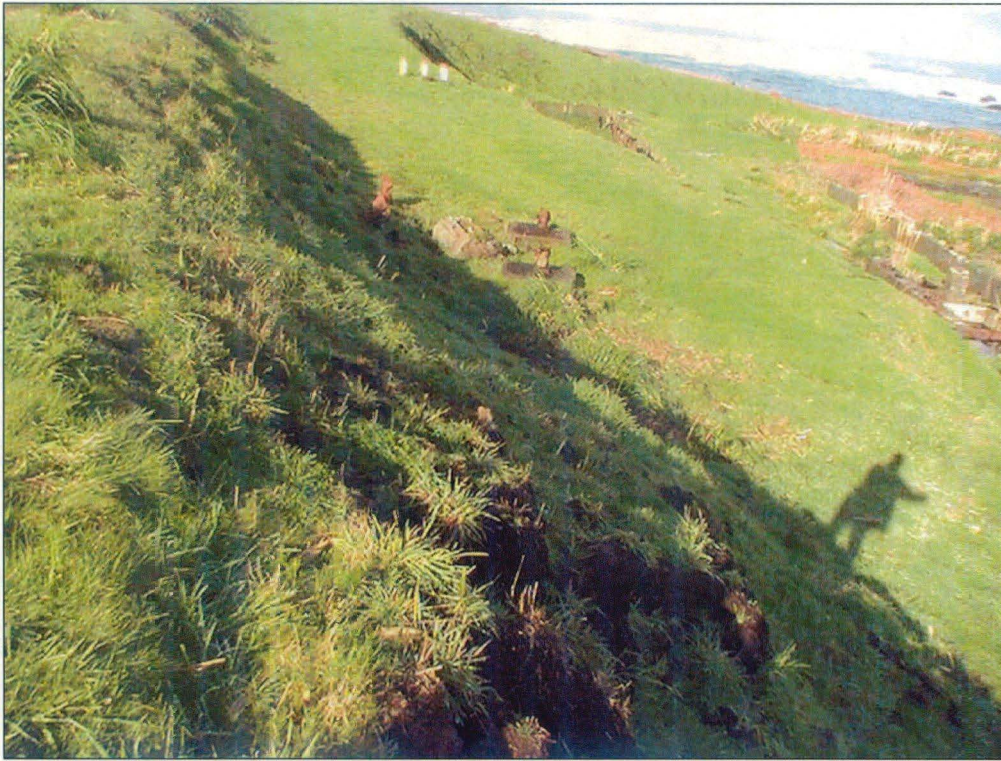
View of the north wall looking towards west, showing surficial sloughing
